Technical conservation plan for an architectural detail in the Khan El Faranj

Nika Bogdanić Saving the Stones January 2014

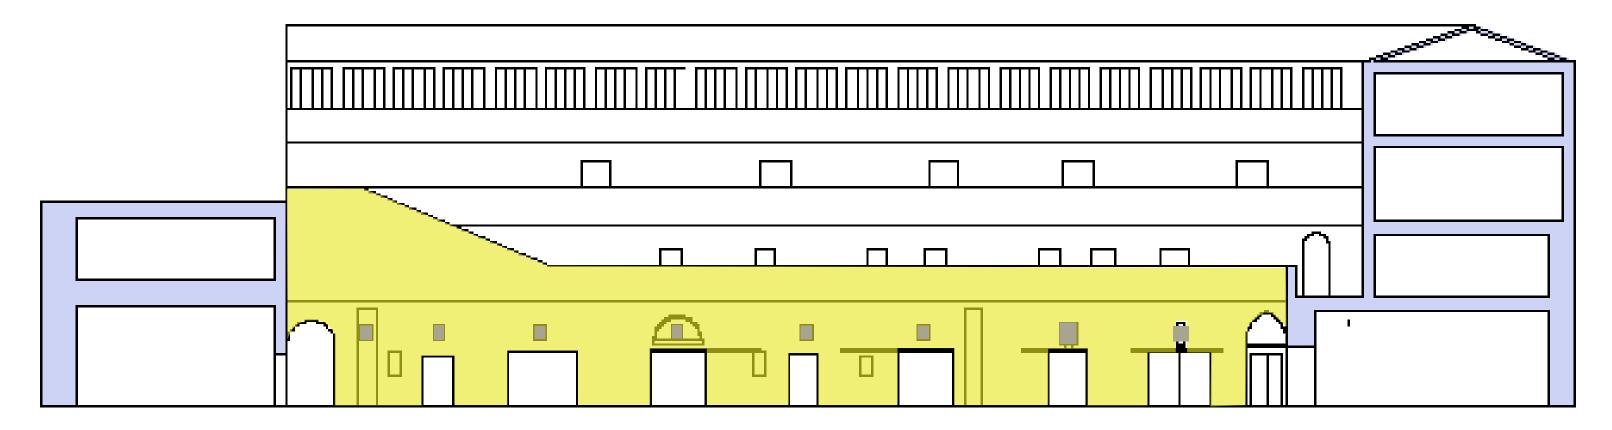
Legend: -Sandstone -Limestone

- Sandstone has been used to build the walls, and the details have been carved in limestone. The walls have been treated with cement, so in some of places the original material is not visible

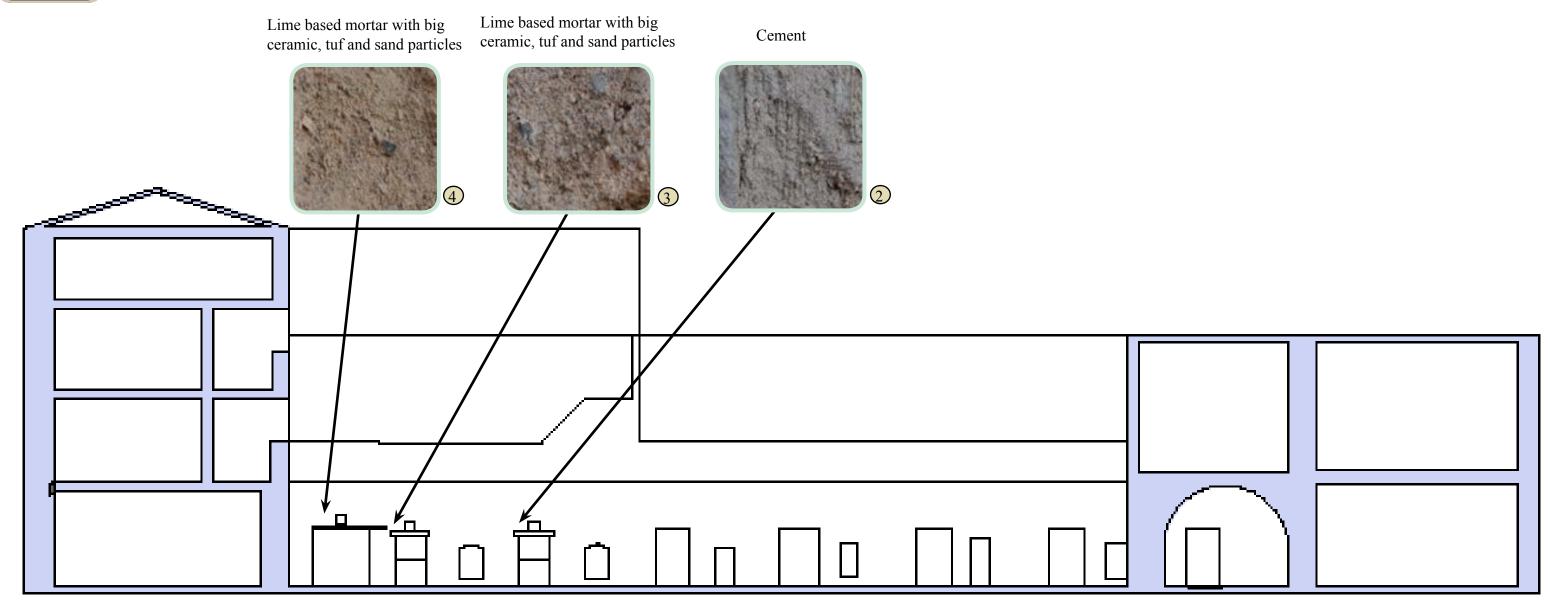
East facade

- Cement is the material we can see here the most. There are different kinds of cement used as treatment, so they cover the original material. There is hydraulic lime baed mortar around 2 pilars, and a lime based mortar with ceramic, tuf and sand particles aroun the 3 out of 5 Franciscan logos

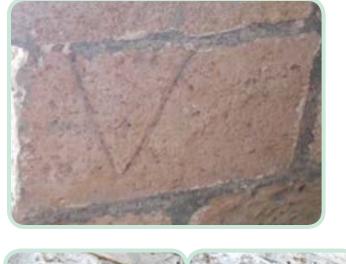
A V shaped sign (not identifiable) ingraved into a crusaders stone (inside of the garage, on the north side of the Khan) with historical value, and less technological and artistic value.

Physical condition: 2

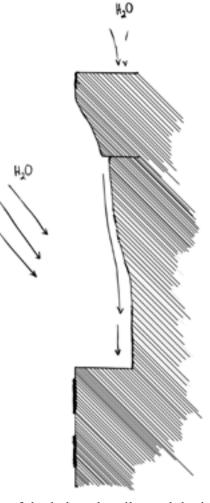
The pilar and its ledge are causing more problems to the element than the element itself.

1) WATER DRAINAGE

- through a crack on the ledge water comes in and falls down straight to the inscription sansdstone

- the whole building has got problems with water drainage with needs to e handled first in order to be able to proceed with the intervention

Section of the ledge, the pilar and the inscription stone drawing - to demonstrate how water enters

1) CLEANING OF THE ENTIRE AREA 2) REPAIRATION OF THE LEDGE

- a) to clean the ledge from the biological attack : herbicide, fungicide treatment with ALGAE CONTROL BPS 7111 -apply it with a brush, and after clean it with water
- b) joint filling of the hole in the ledge
- c) impregnation with IDROREPELEN IMPREGNATION MATERIAL

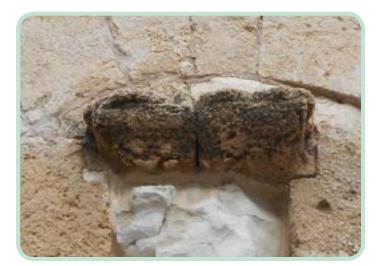
4) CORROSION ON THE LETTERS

- the time and the weather condition caused corrosion on the led

-Deterioration of the sandstone

5) MECHANICAL CLEANING OF THE LETTERS

a) clean the letters mechanically using a skalpel and a brush

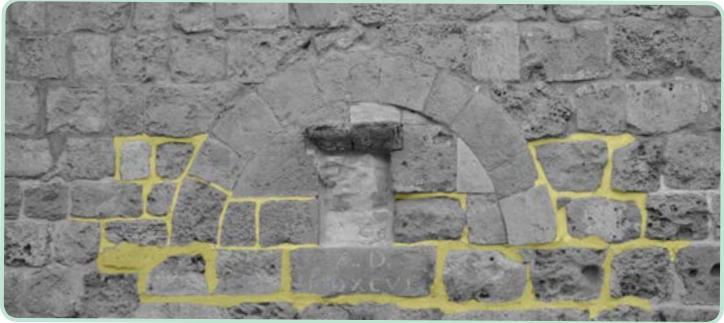
5) PREVIOUS CEMENT INTERVENTION

- not only does cement pressure the stone and does not allow the area to "breathe", it is also estetically bad - the estetics of this element and it's homogeneity is of big importance

The yellow indicates where the cement should be replaced with hydraulic lime mortar with sandstone particles

- c) remove the cement
- d) put the hydraulic lime mortar with sandstone particles where the cement was

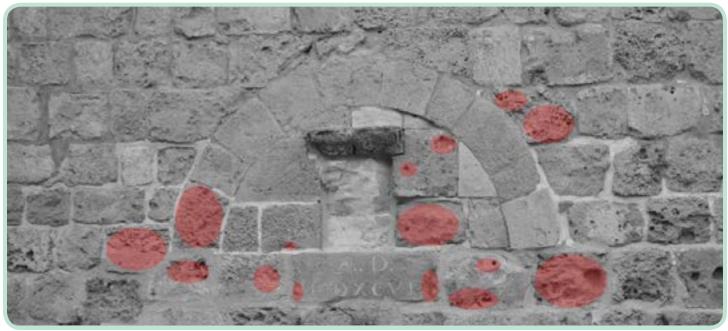
6) STONE DETERIORATION

- there are places where the sandstone is more deteriorated due to cement pressure and the water that enters; however the sandstone is in a pretty good condition

The red indicates the deteriorated sandstone
