Documentation of the floor of the main hall, 2nd Story, The International Conservation Center, Citta' di Roma

This project was accomplished within the framework of
Saving the Stones, Practical Conservation Program
February 2011 - July 2011
Akko, Israel

Abstract

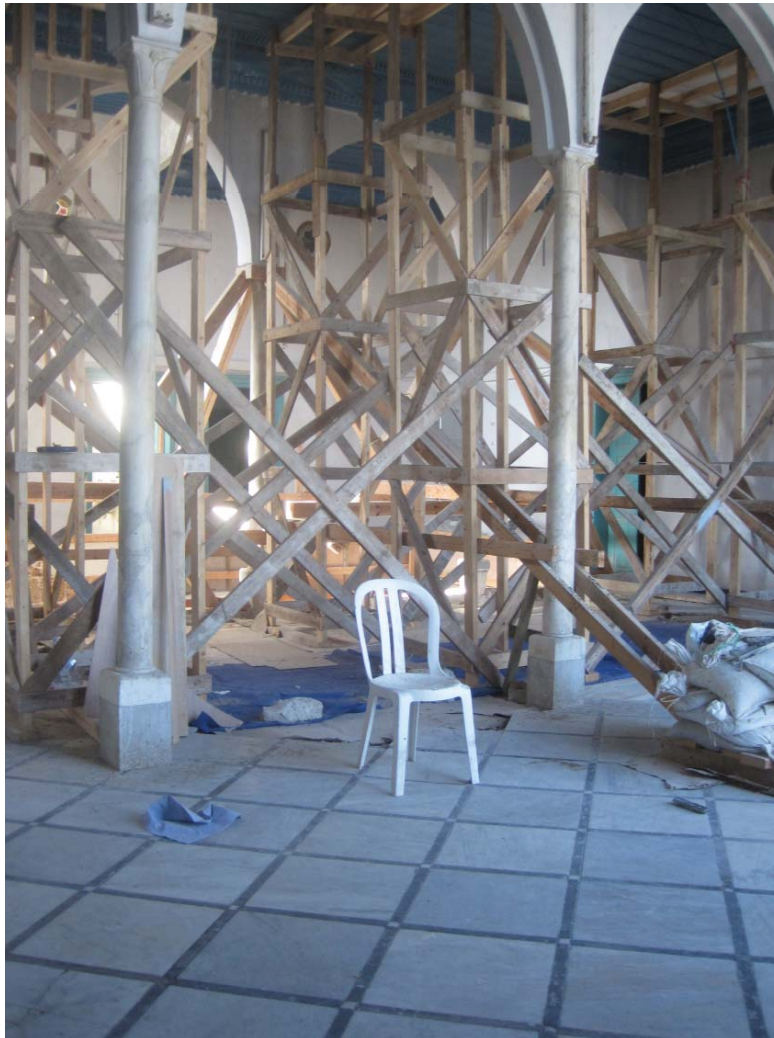
The floor in July 2011. Wood scaffolding has been installed to stabilize the roof (photo: Yano Rivera)

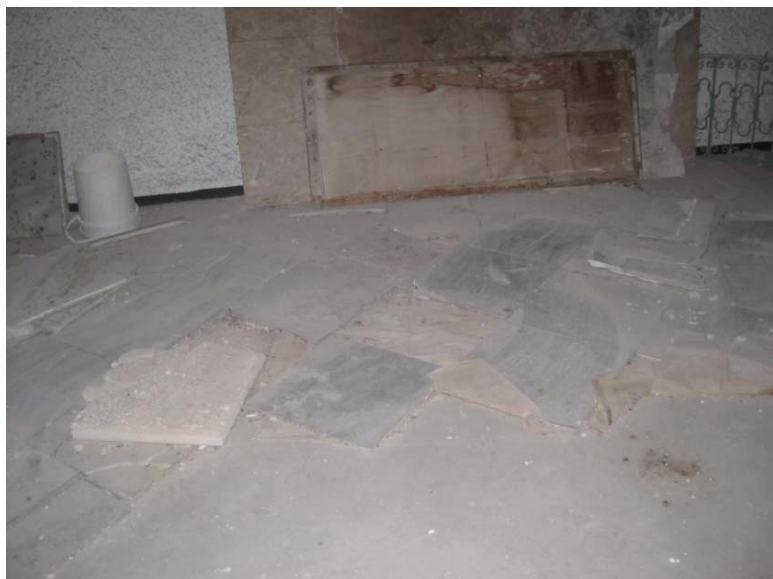
Part of the floor had to be removed in order to change the rotten wooden beams underneath them. Before removal, all the marble was documented and carefully moved to the adjoining room. They have been set temporarily in the exact order as they existed originally.

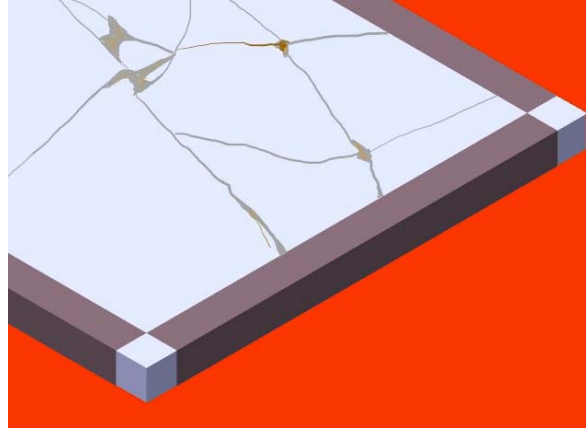
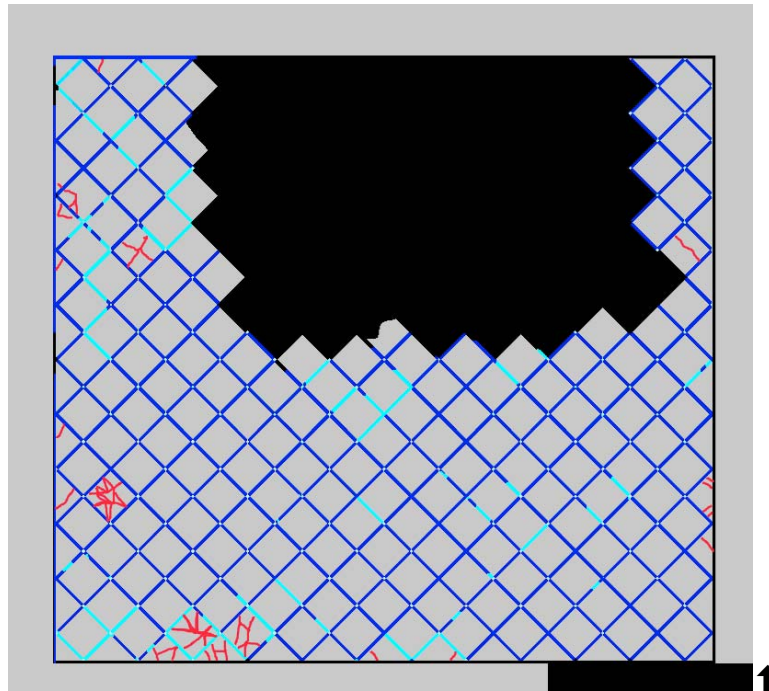
Marble covers a large section of the floor. The large square pieces, and most of the small square pieces are made of tile. It is gray tile. The large marble tile has a pattern of deterioration that is characterized by cracks. Cracks in the marble are drawn with red lines.

Filling in cracks between the marble. Filling in lacunae in the surface of the terazzo.

Exchanging deteriorated marble as needed.

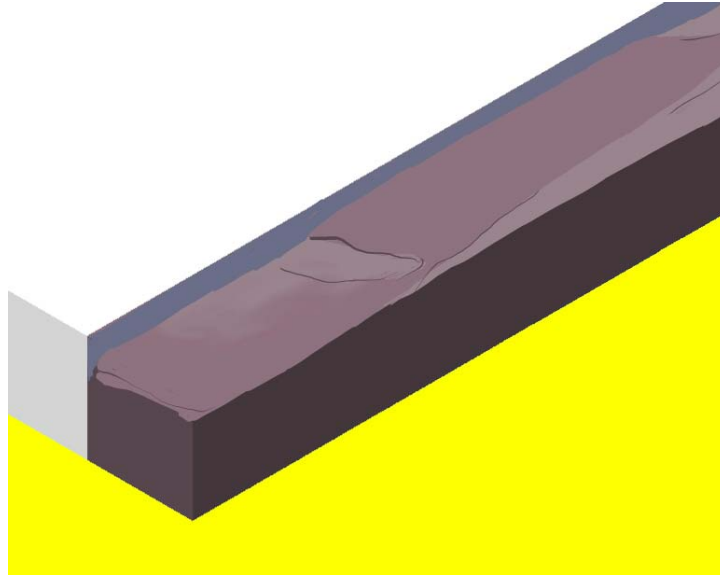
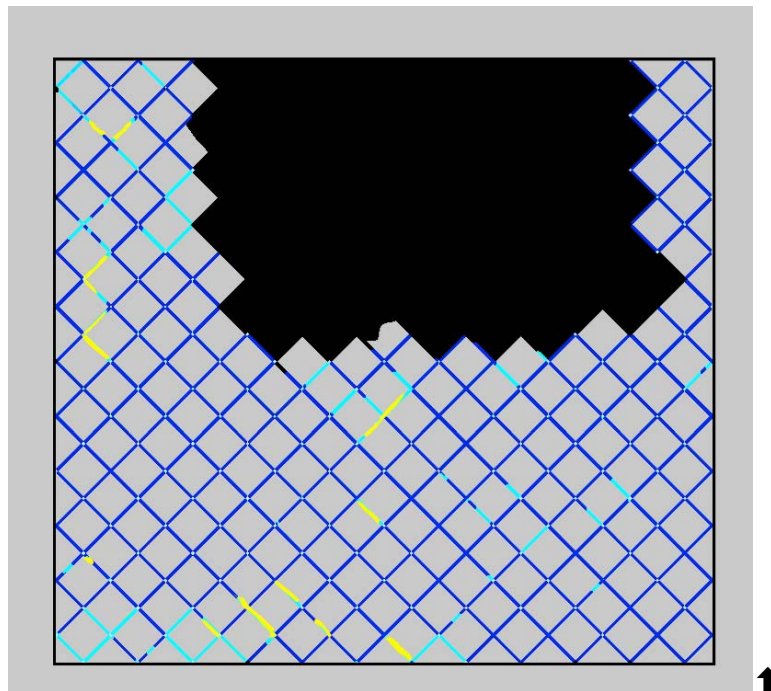
Schist

The schist tiles have a pattern of deterioration that is characterized by erosion. The top face of their surfaces flakes off, and this causes the surfaces to dip. It is the inherent vice of the material, as schist is a metamorphic rock, made of layers squished on top of other layers. Some areas of schist are more problematic than others, and only the more problematic schist is indicated on the map by yellow.

Exchange of deteriorating schist for new schist, as needed.

Application of a protective coating, to stop or slow the deterioration of the existing schist.

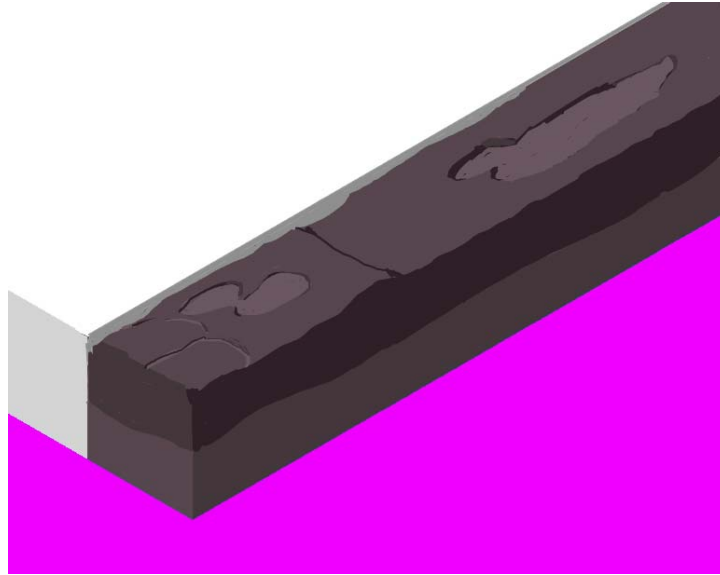
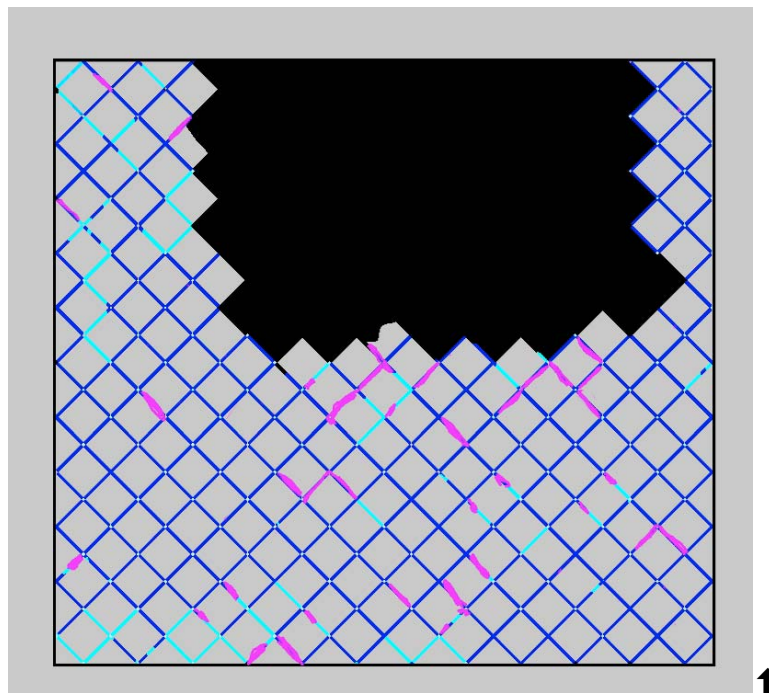
Terazzo is a concrete infill, placed on top of eroded schist. Terazzo's surface deteriorates by showing *lacunae*, and the decking/flaking edges. It is a problems that the material exhibits throughout the floor in general. Particularly problematic pieces of terazzo are delineated through the map in purple. There appear to be different kinds of terazzo throughout the floor.

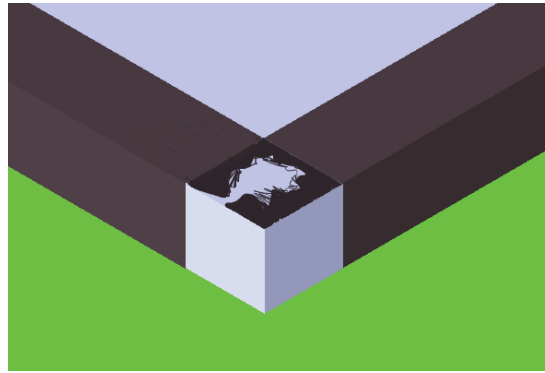
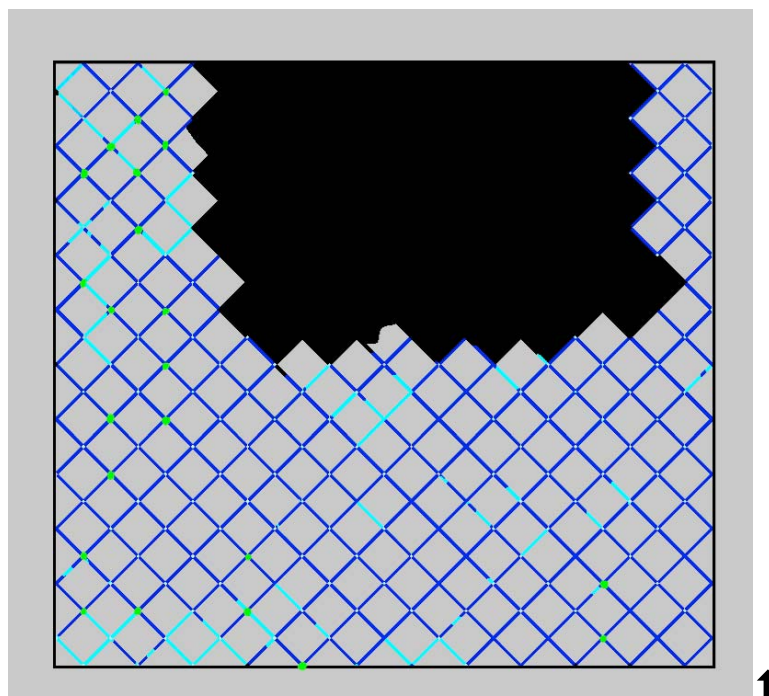
Small Marble

The small marble tiles sometimes get covered with terazzo, which spills over from the schist on to the small tiles. These spills are leftover from what appears to be the painting of terazzo. The problem of spilling over is present throughout the floor in general. Tiles that are particularly spilled over have been pointed out in green.

Removal of bird droppings and paint, to reveal original appearance of floor surfaces.

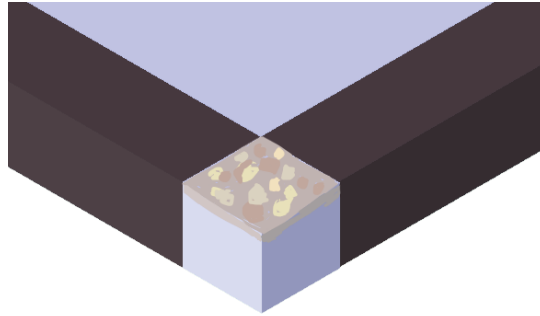
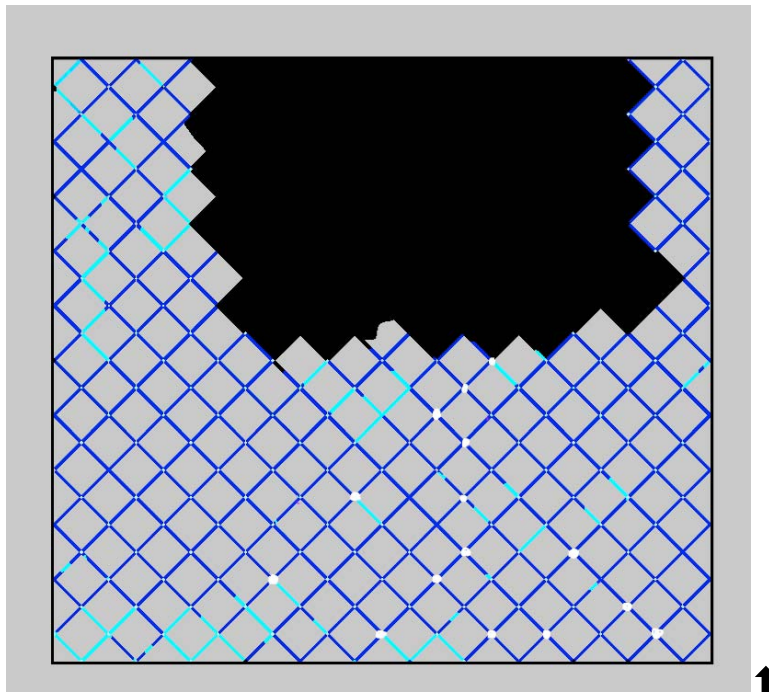
White Terazzo

The white terazzo is made of a piece of a common terazzo tile cut to fill missing small marble squares. These small square corners are an anomaly of the floor, and they reveal something about the history of previous conservation efforts of the floor, mainly, where pieces of small marble tile are missing. They are pointed out in white dots on the map.

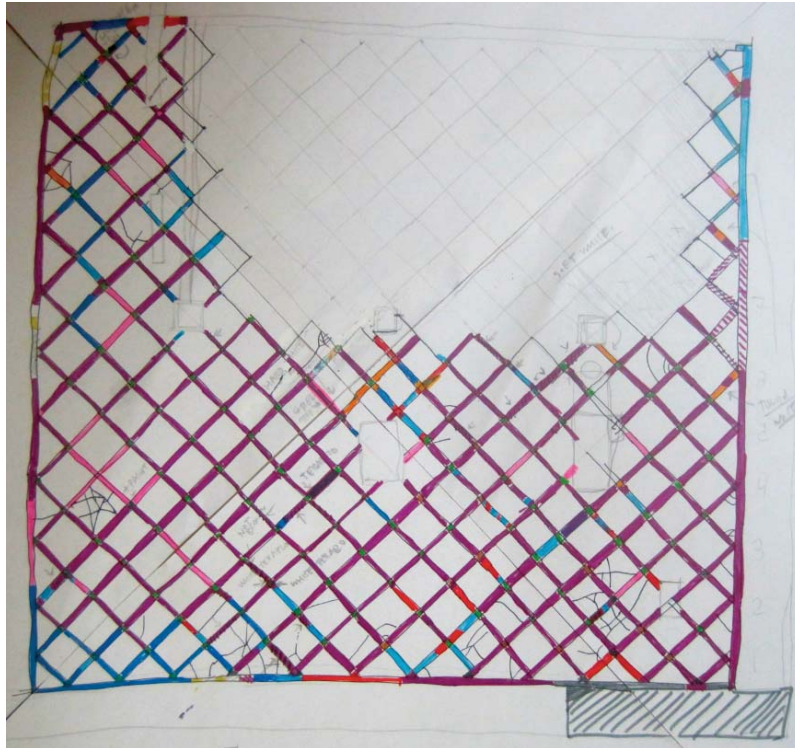
Pathology Map

The full documentation of the floor is a hand-draw document. It includes all the pathologies piled on top of one another.
