Seismic Risk Preparedness and Mitigation of Culture Heritage Sites
מוכנות והיערכות לסיכונים רעידות אדמה באתרי מורשת תרבות

ירושלים. יח' יט' בשבט, תשע"ד Israel, Jerusalem. 19-20 January 2014

Risk Map of Culture Heritage Sites in Israel- Seismic Risk to Archaeological Sites

Michael Cohen, Israel Antiquities Authority Conservation Department

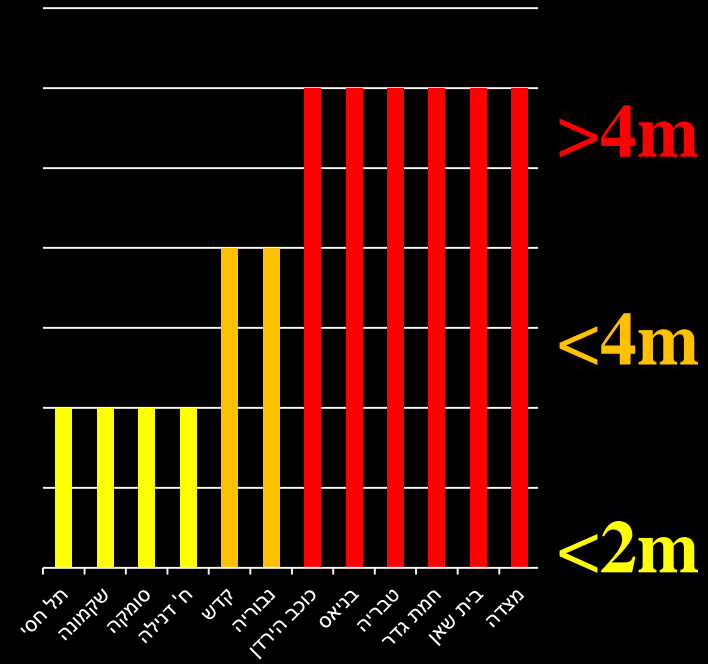
Final results of sites evaluation according the 3 parameters: Location, Value/important, Height

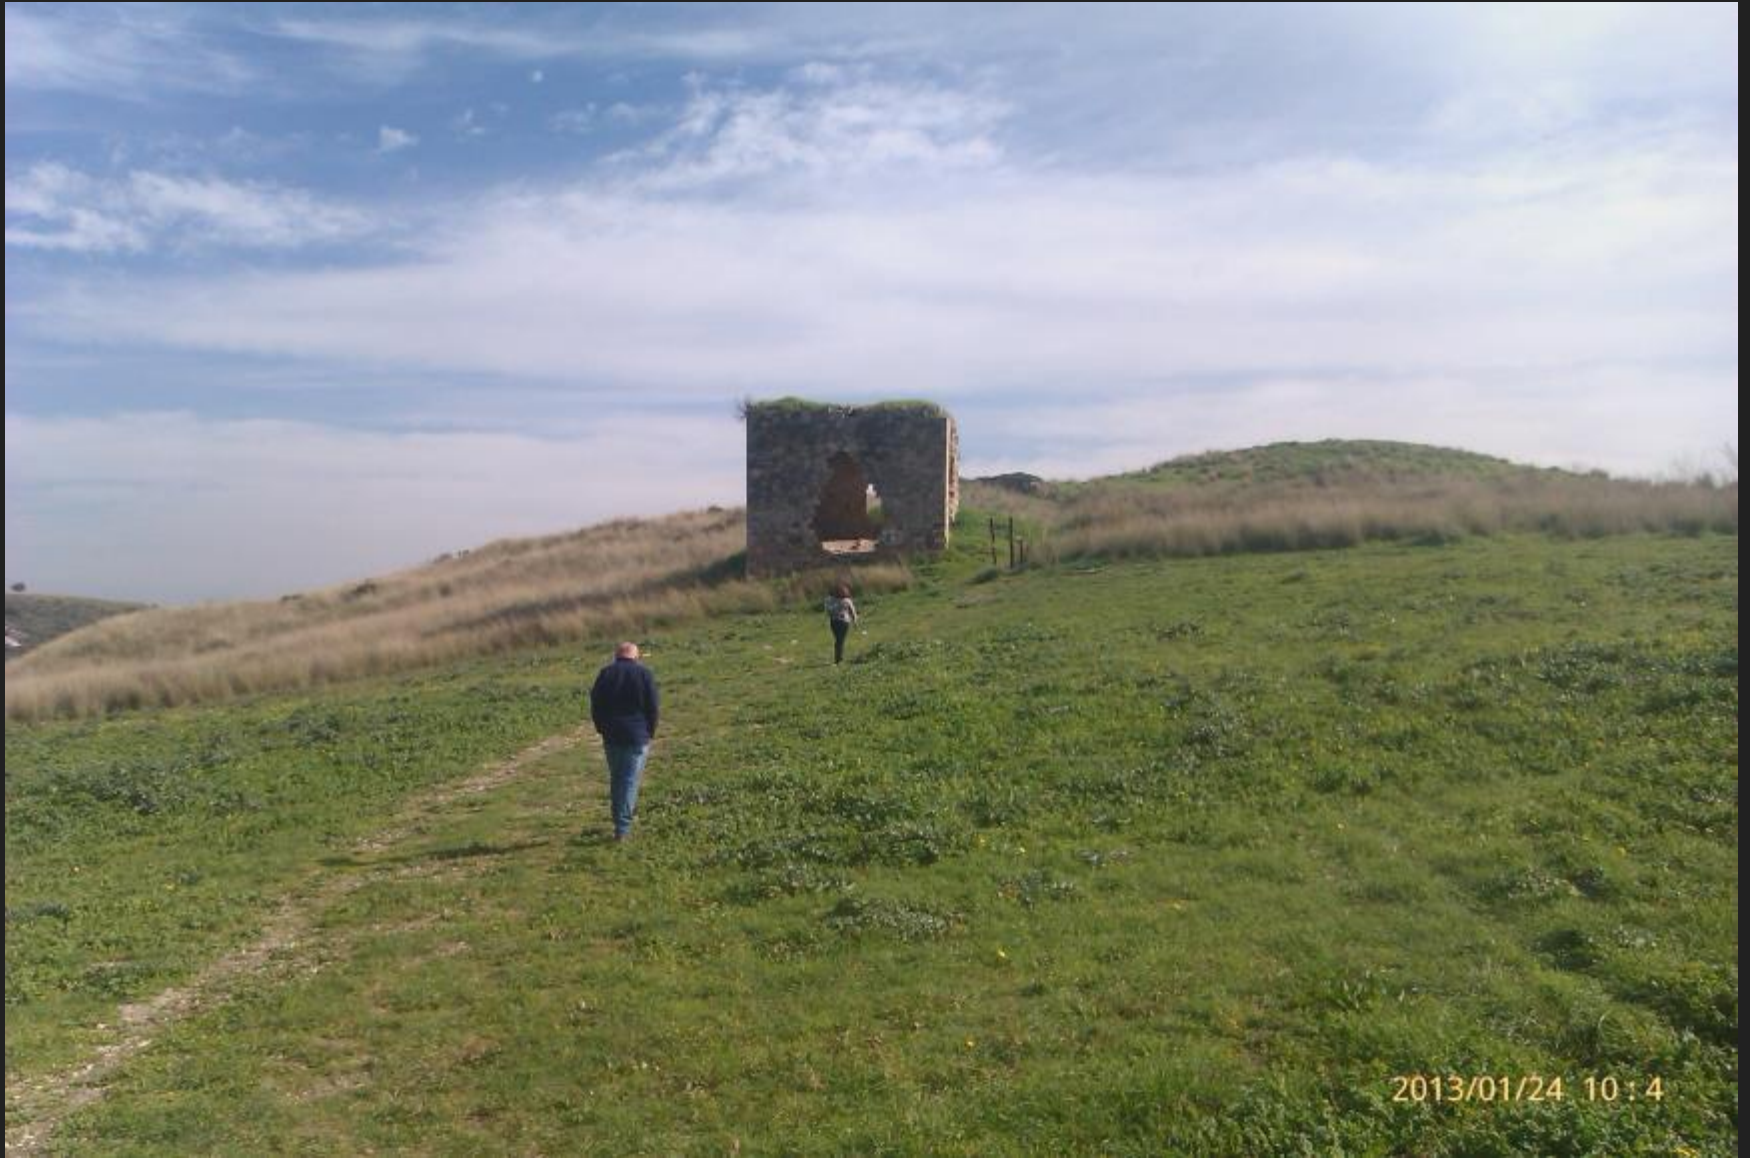
Evaluation of a single Structure

Khan Kiri, Yokneam

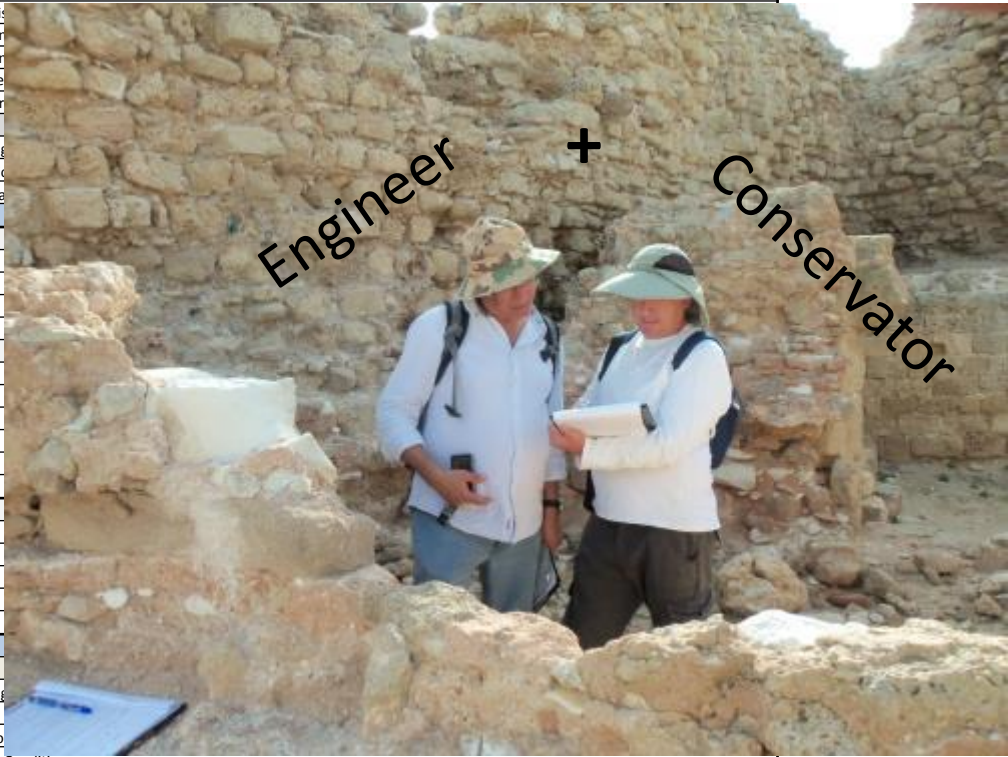
Engineering and conservation state

No	-	Yes	Σ	
instability of constructive elements which endanger the structure	1	2	3	4	0
Lack of constructive elements which endanger the Structure (beam/ vault/ arch/ pillar)	1	2	3	4	0
Lack of 3D connections between constructive elements (foundations / walls/ roof/ ceiling/ columns)	1	2	3	4	0
Slenderness (the proportion between the tall and wide) 1) 1: 4 / 2) 1:6 / 3) 1:8 / 4) 1:10	1	2	3	4	0
Existence of deformation (sinks, blows, attitude) that can endanger the stability of the structure	1	2	3	4	0
Existence of vertical / horizontal / diagonal constructive cracks that endanger the stability of the structure					
Adjacent construction that endanger the structure					4 0
Modern intervention that endanger the stability of the structure					4 0
					0

Physical - conservation state

Lacking bricks/blocks/mortar/element	Lacking of elements the endanger the structure				4	0
Deterioration	Deterioration that endanger the structure				4	0
Vegetation	Vegetation that endanger the stabilizing				4	0
						0

Risk Evaluation Form

Risk Map - Structure Card												
Date												
Site												
Name of the Building/complex												
Reference												
Site serial number												
Fill duration in minutes												
Type of the edifice remains				not calculated			Structure, Complex, Part of complex, Colonnade					
Materials				Concrete, Basalt, Lime stone, Sand stone, Other								
Mortar				Lime, Cement, Mud, Epoxy								
Technology				One leaf, two leaves, three leaves, colonnade								
Integrity				3D connections								
Elevation				0			Multiplicity					
Height (absolute)				0 3 2 1			High ----- Low			3) more than 4m - 2) 2-4m - 1) up to 2m		
Engineering and conservation state				0			Automatic					
Collapse				0 4 3 2 1			yes ----- no			Existence of collapse that endanger the Structure		
Dismantled				0 4 3 2 1			yes ----- no			Existence of dismantling of structural element that endanger the Structure		
3D connections				0 4 3 2 1			yes ----- no			No existence of 3D connections of structural element that stabilize the Structure

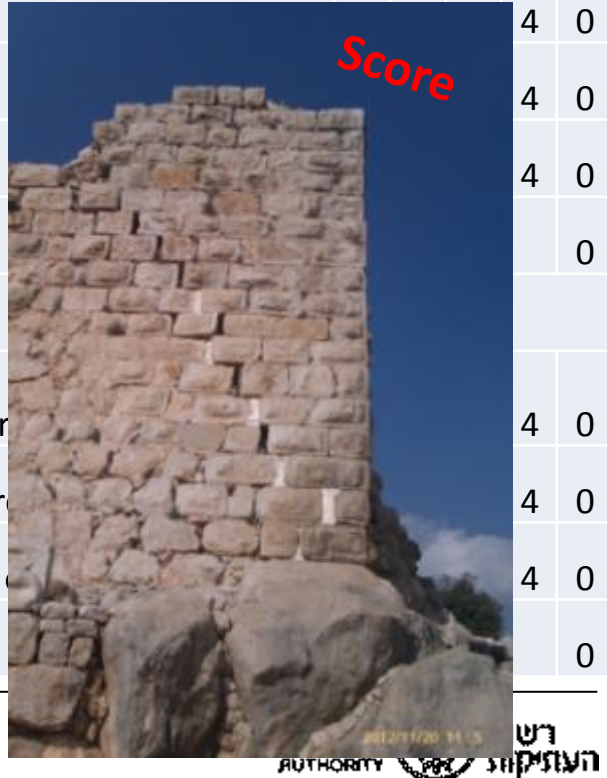
Engineering and conservation state

No	-	Yes	Σ	
instability of constructive elements which endanger the structure	1	2	3	4	0
Lack of constructive elements which endanger the Structure (beam/ vault/ arch/ pillar)	1	2	3	4	0
Lack of 3D connections between cons					0
Slenderness (the proportion between					0
Existence of deformation (sinks, blow					0
Existence of vertical / horizontal / dia					0
structure					0
Adjacent construction that endanger					0
Modern intervention that endanger t					0
					0
					0
Physical - conservation state					
Lacking bricks/blocks/mortar/elemen					0
Deterioration					0
Vegetation					0
vegetation that endanger the stabilizing of the structure	1	2	3	4	0
	Total				0

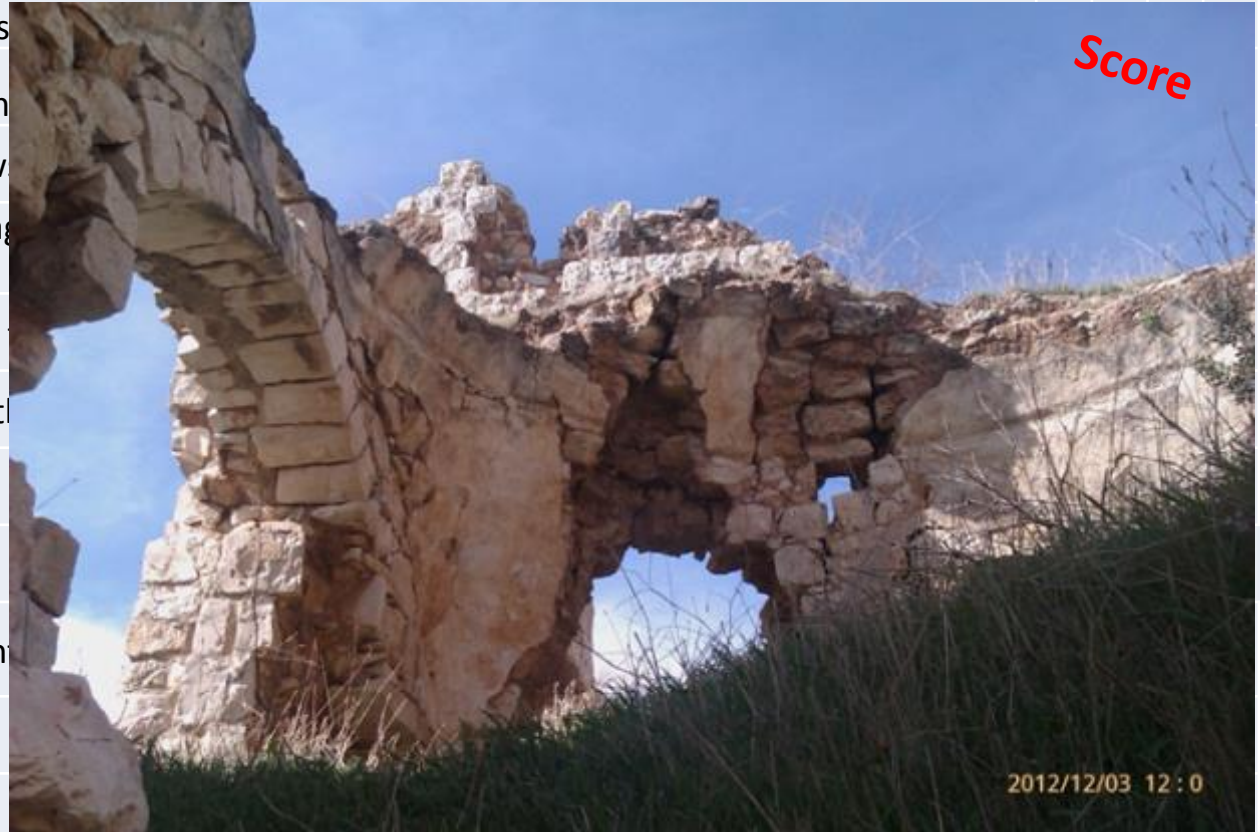
Preliminary Risk Assessment results of Archaeological Sites - Pilot (2011-12)

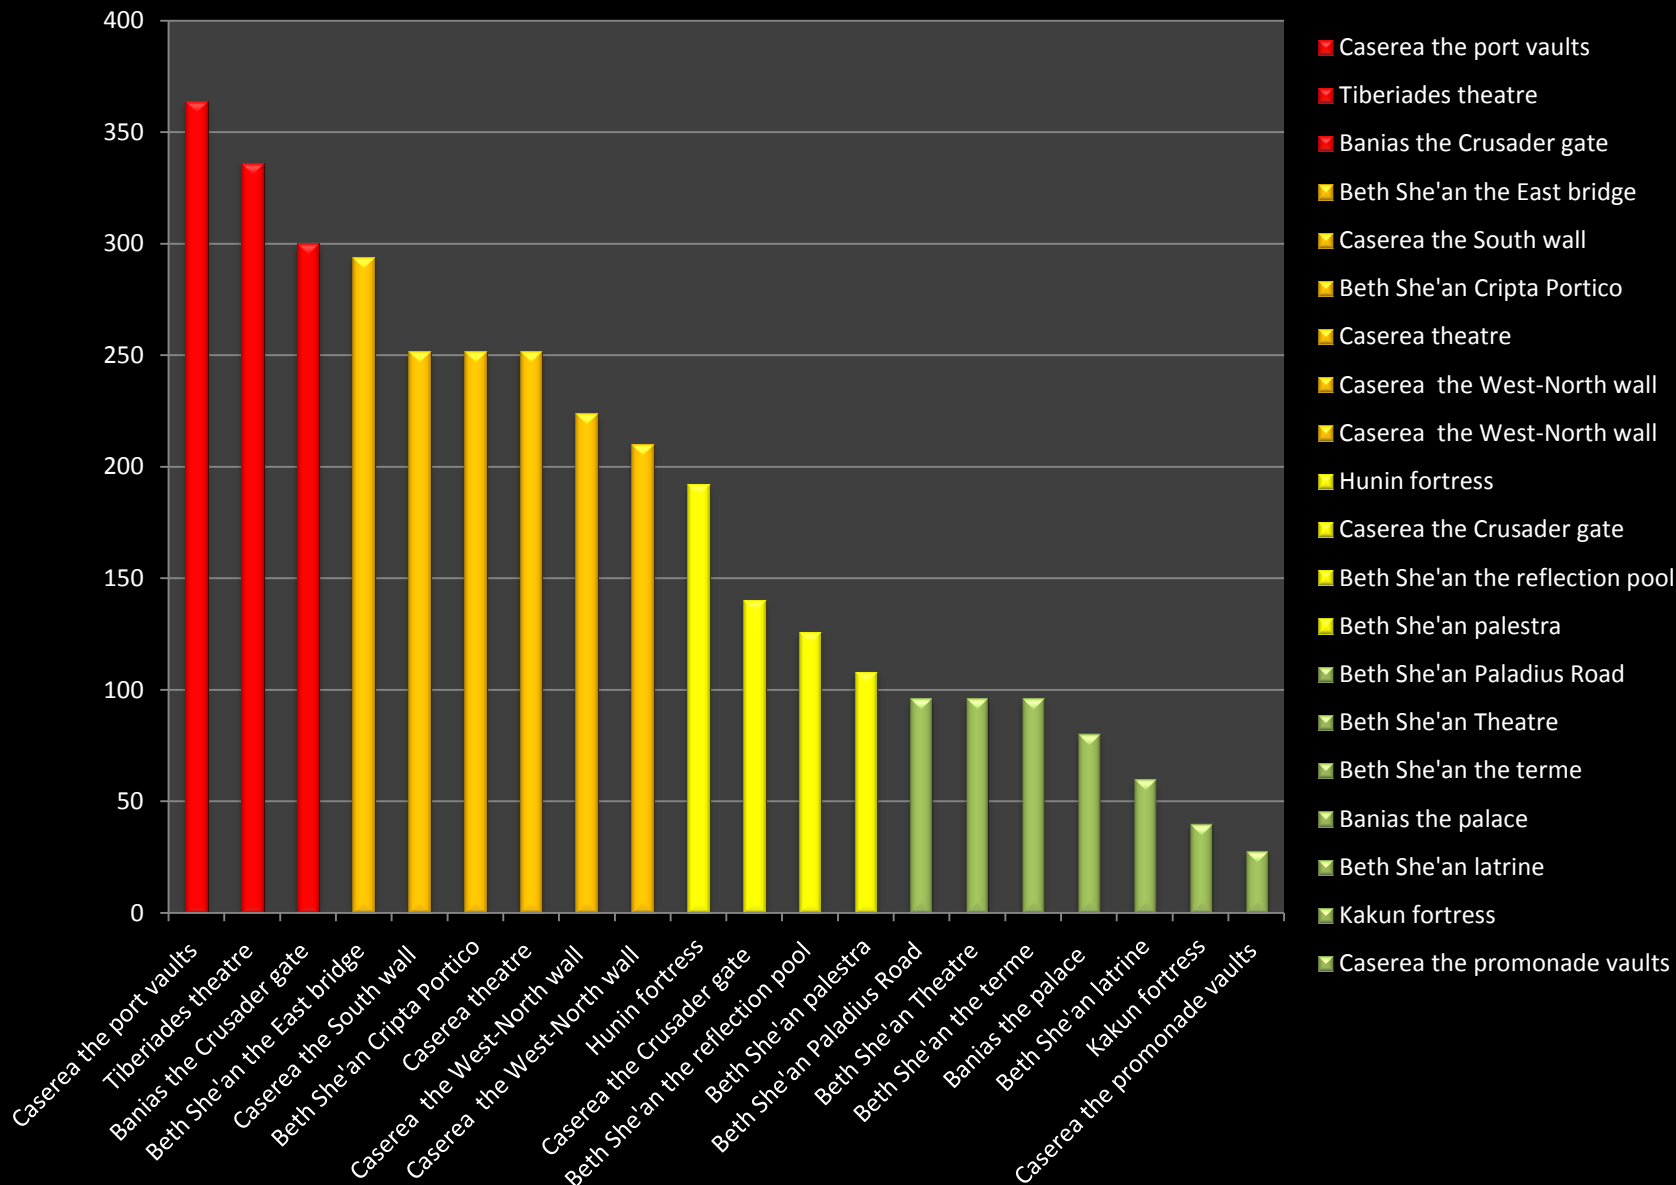
Critical

High

Medium

Low

Preliminary pilot results – risk assessment of CH structures

Preliminary Conclusions – Archaeological sites

- Seismic Risk preparedness on sites was **neglected** until today even in visited sites
- **Positive experience of a simple model for Risk map**
- The results are validated
- **Structures that were submitted to conservation are usually in good state**

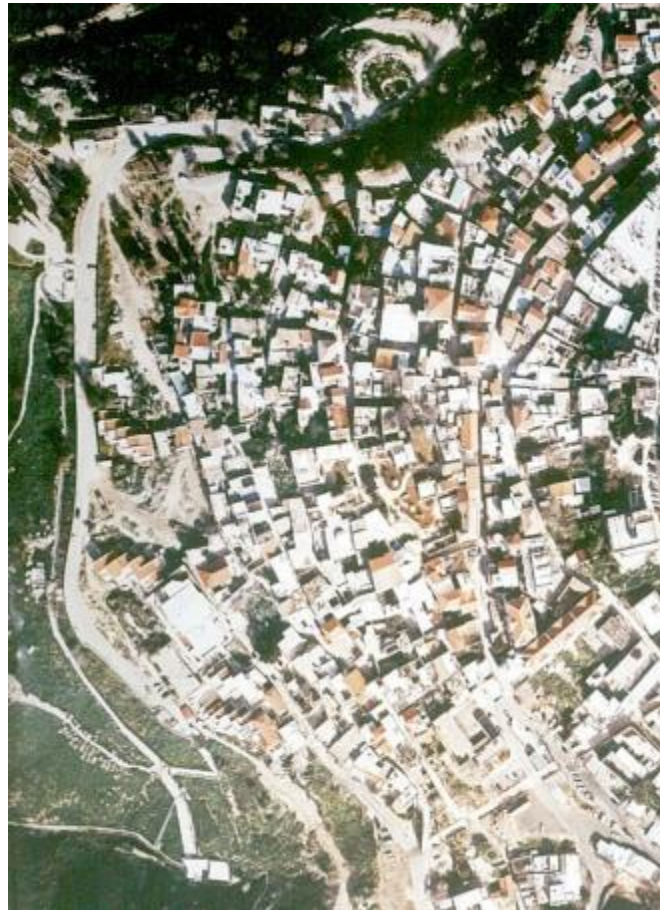
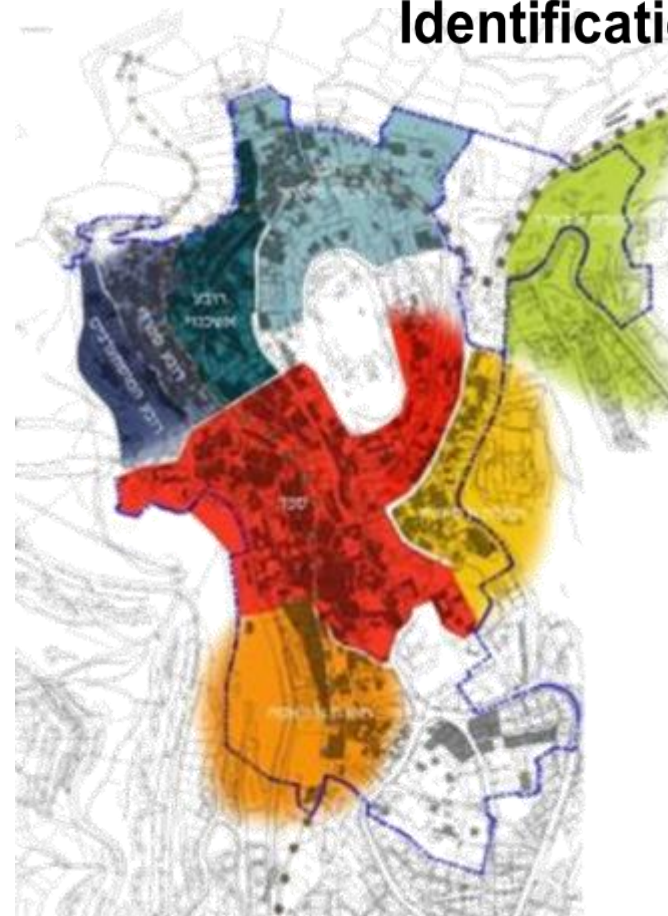
Seismic vulnerability assessment on an urban scale

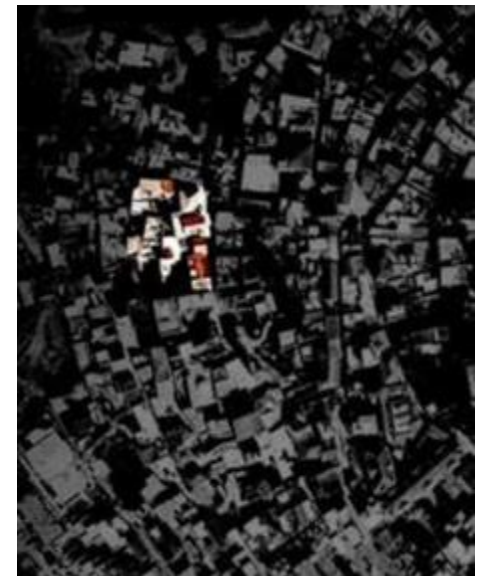
Identification of the blocks
