Kabri-Akko Aqueduct Pipes Building Technique

Part I - Character Assessment

Part II - Dismantling and Conservation Plan

Construction plan: showing the area used for the analysis of the building technology

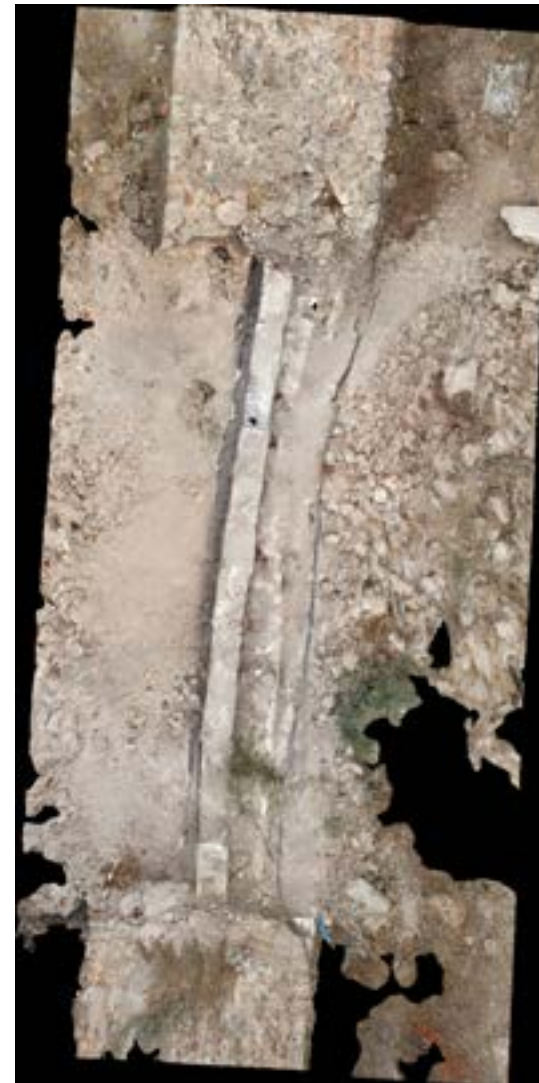
Fig.#

Aerial View of Site, showing remaining stone and ceramic pipes

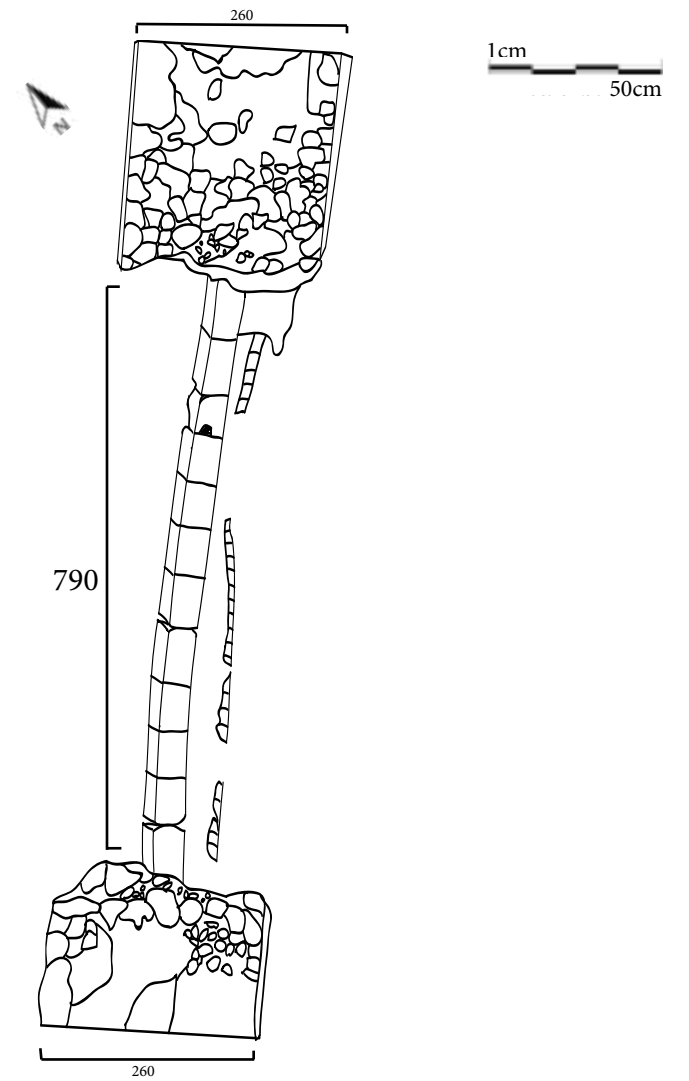
Fig. #

Architectural Plan, showing remaining stone and ceramic pipes

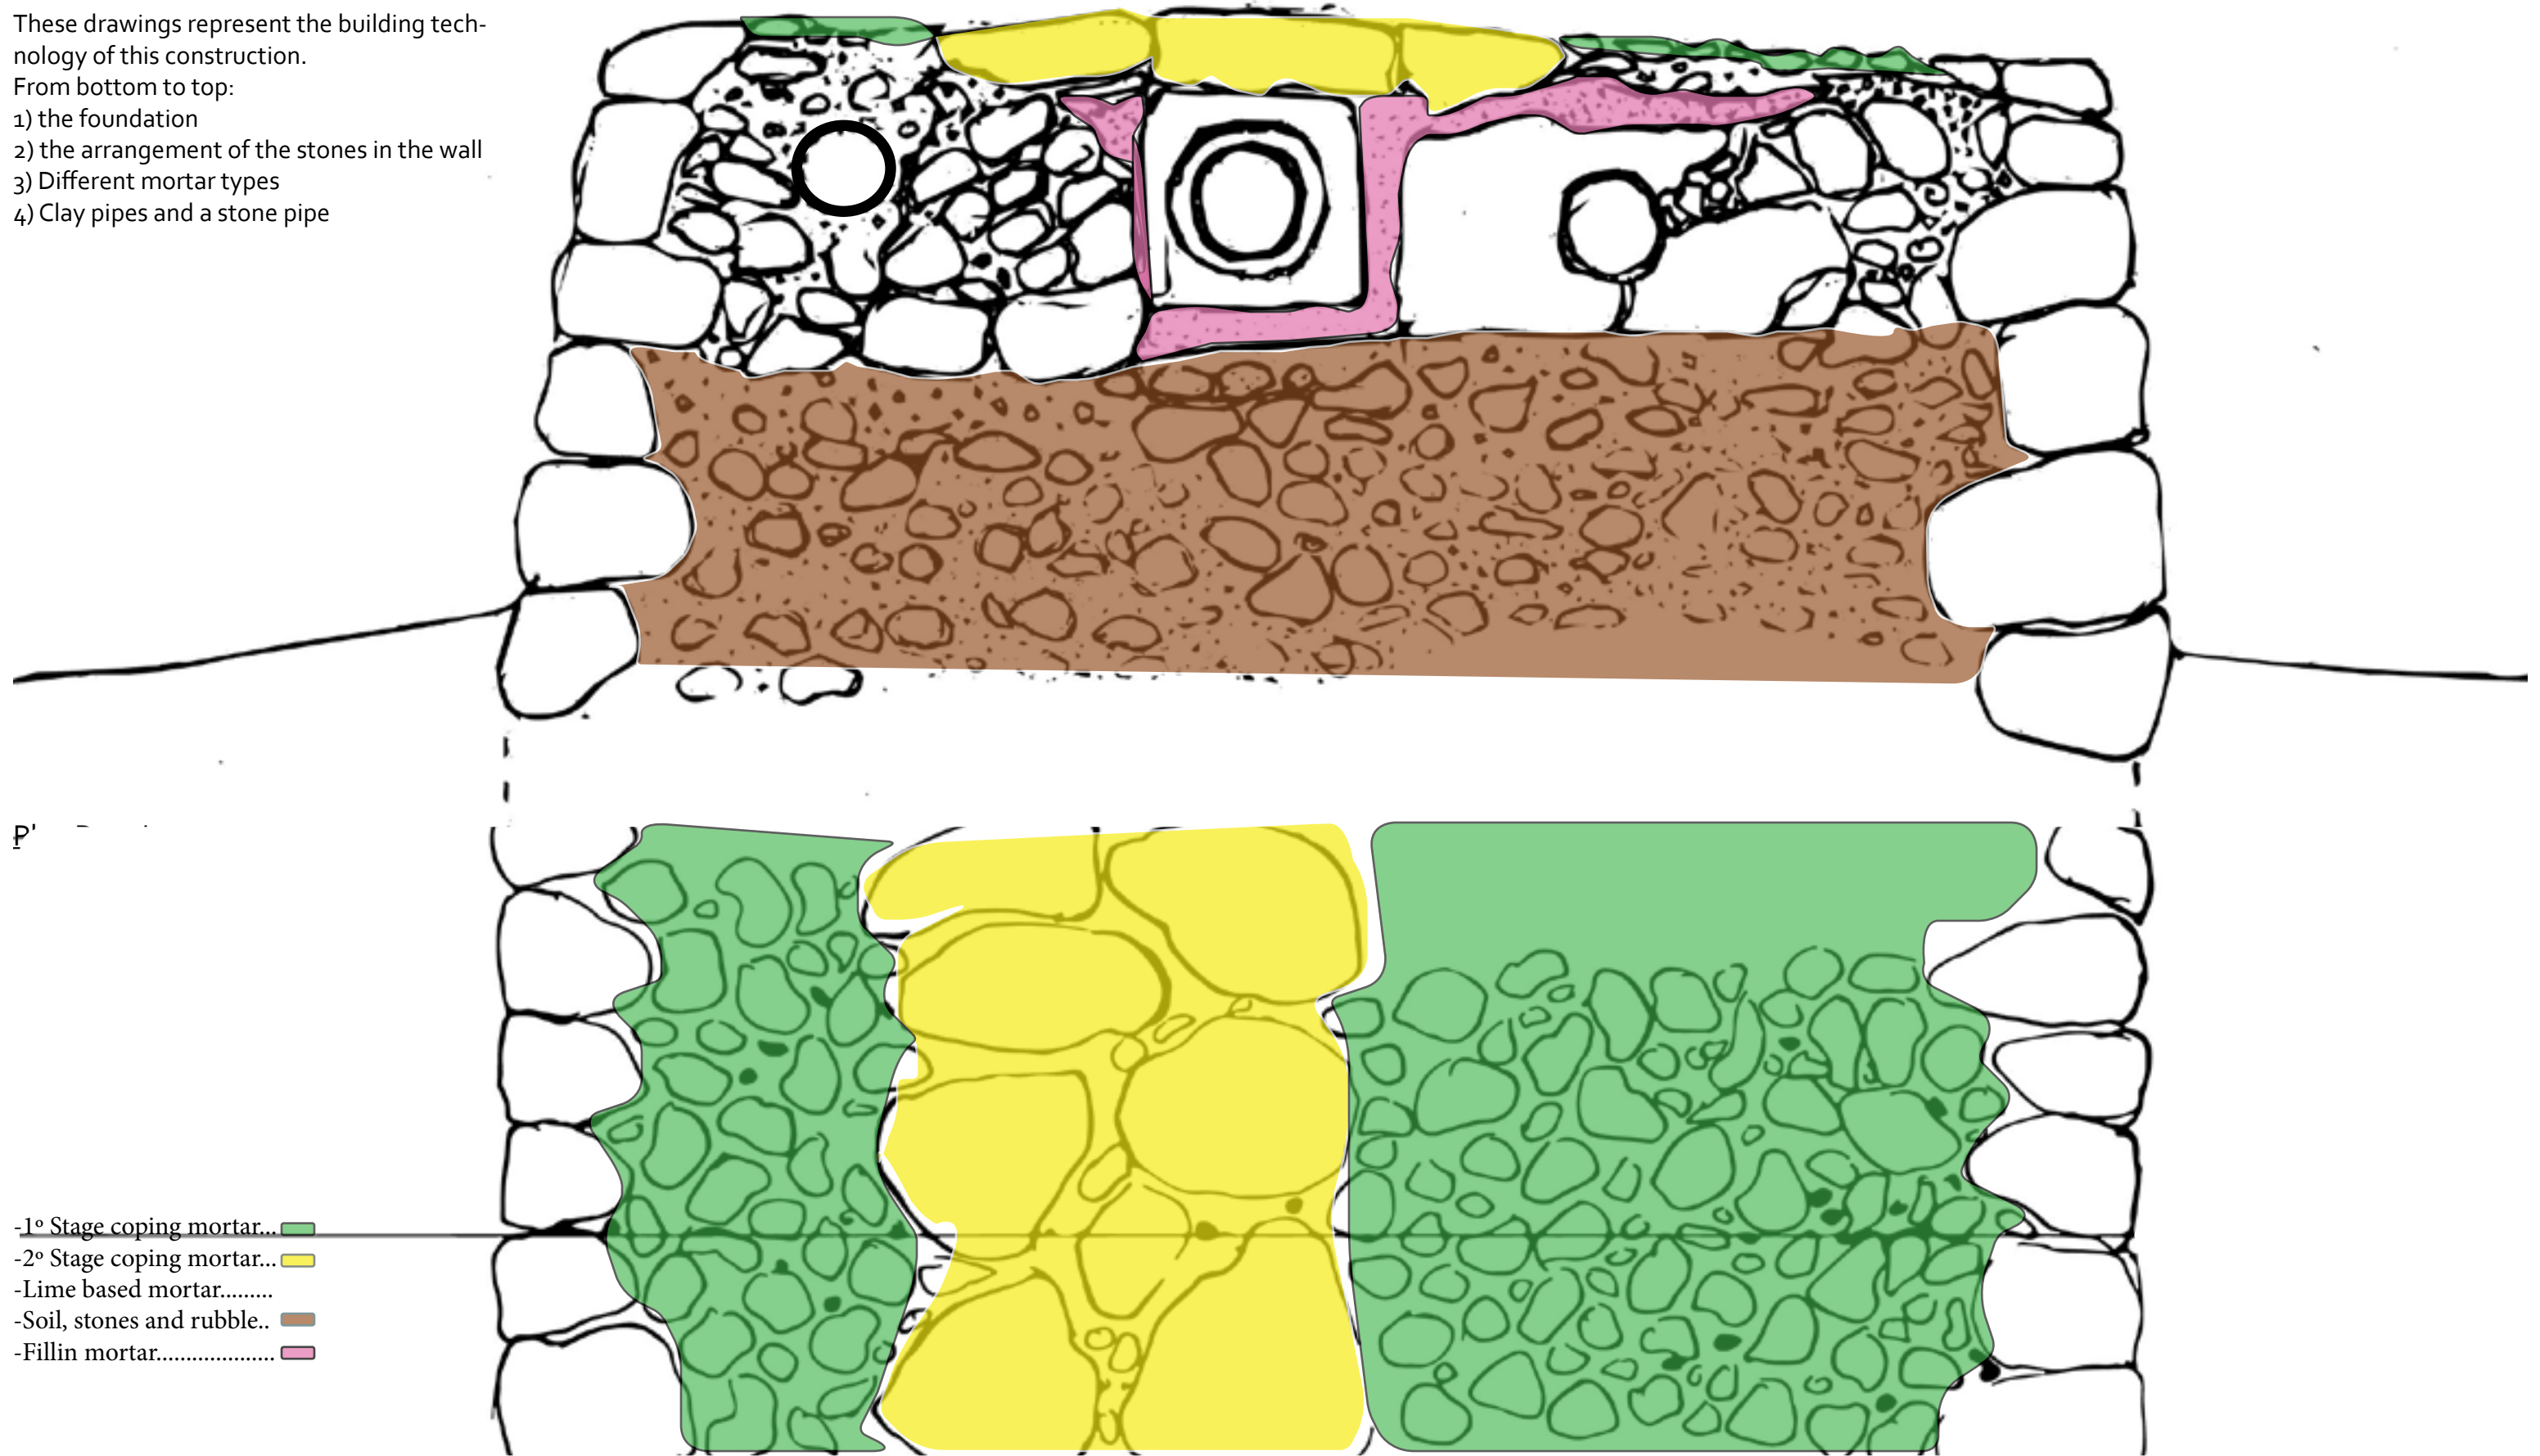
Section drawing

These drawings represent the building technology of this construction.

From bottom to top:

- 1) the foundation
- 2) the arrangement of the stones in the wall
- 3) Different mortar types
- 4) Clay pipes and a stone pipe

- 1° Stage coping mortar... █
- 2° Stage coping mortar... █
- Lime based mortar..... █
- Soil, stones and rubble.. █
- Fillin mortar..... █

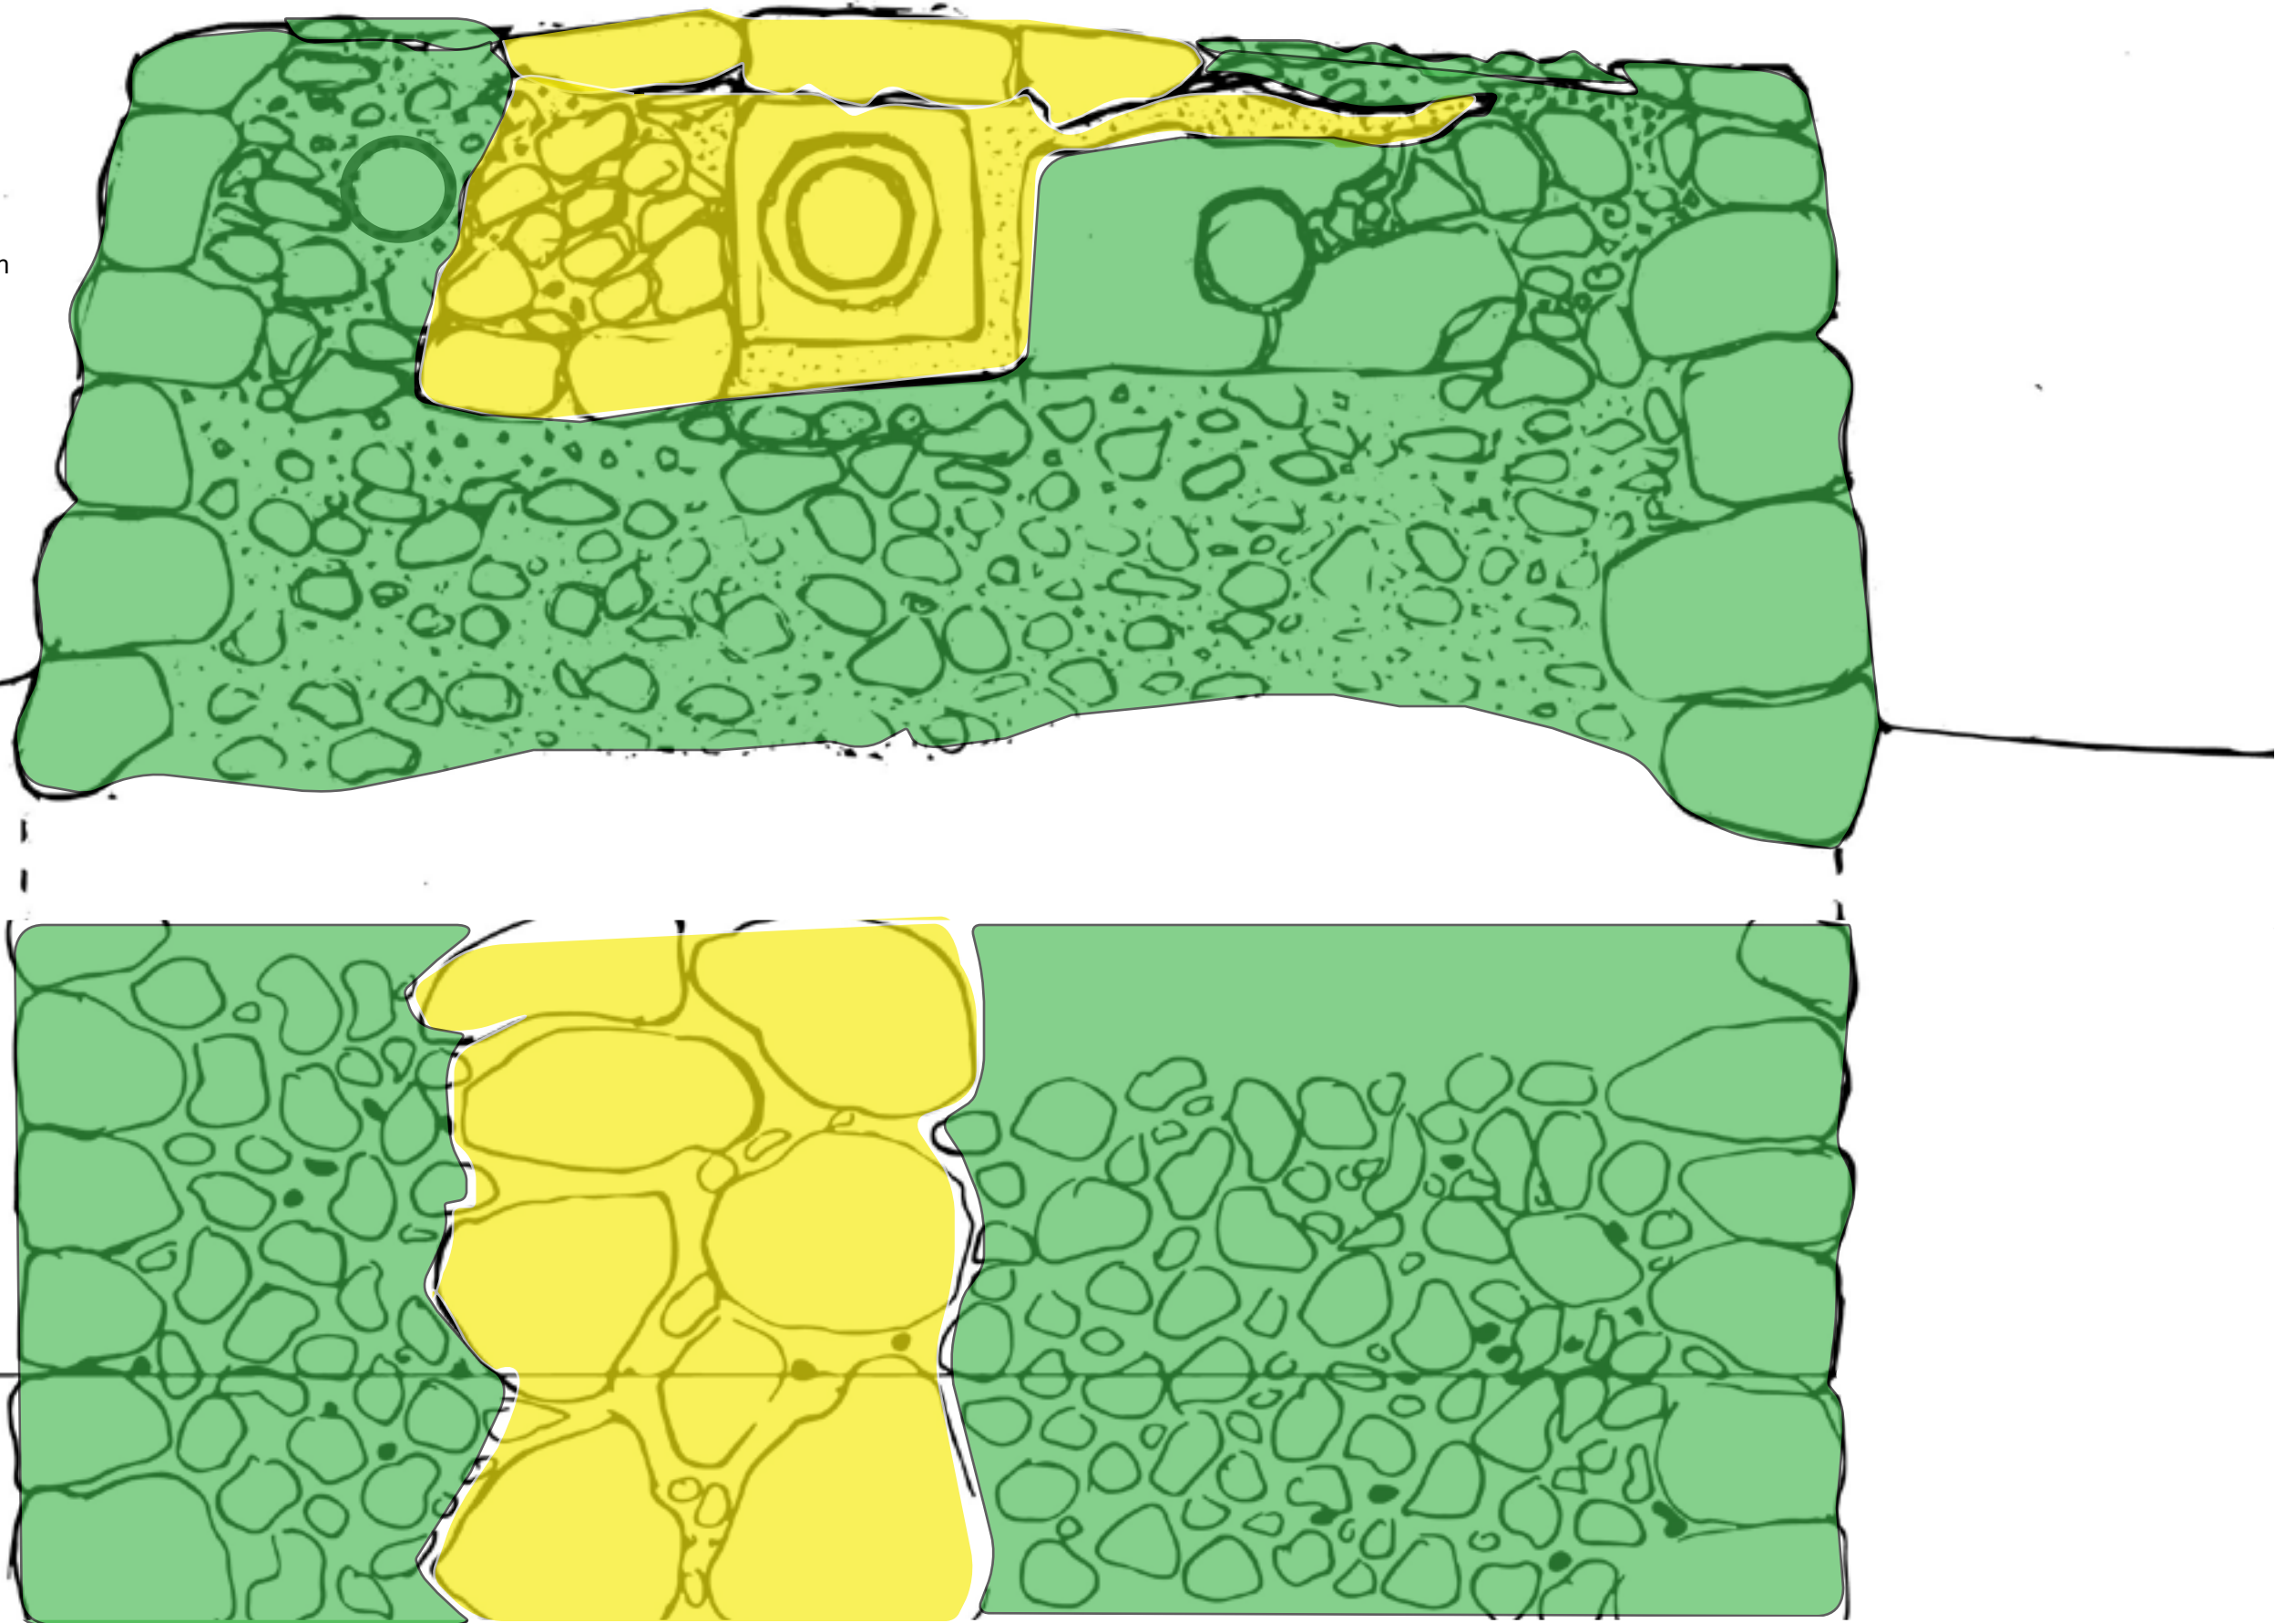
Section drawing

This research has shown that there were 2 different stages of the construction. In the first stage there were 3 clay pipes covered by small stones coping. In the second stage a stone pipe was inserted (1873) to the place of the central clay pipe. So the situation has changed from having 3 clay pipes to having 2 clay pipes on each sides and a stone pipe in the middle.

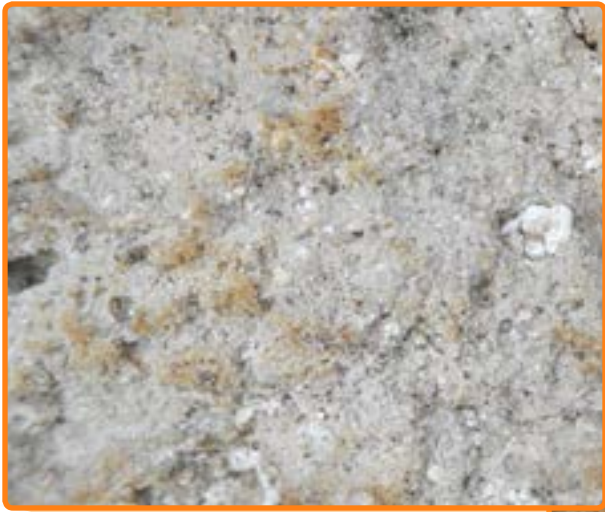
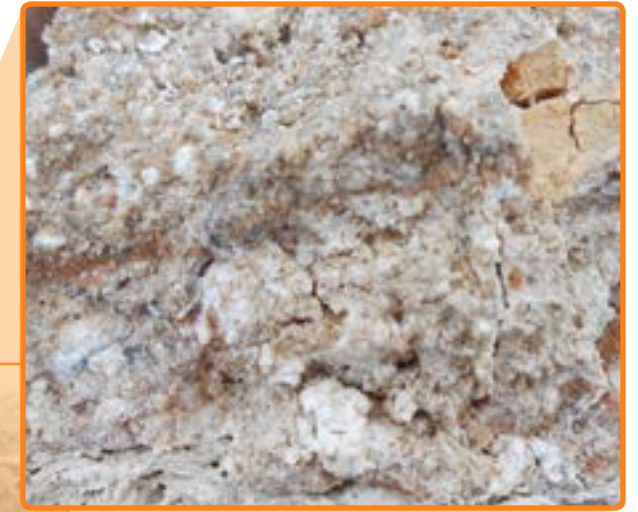
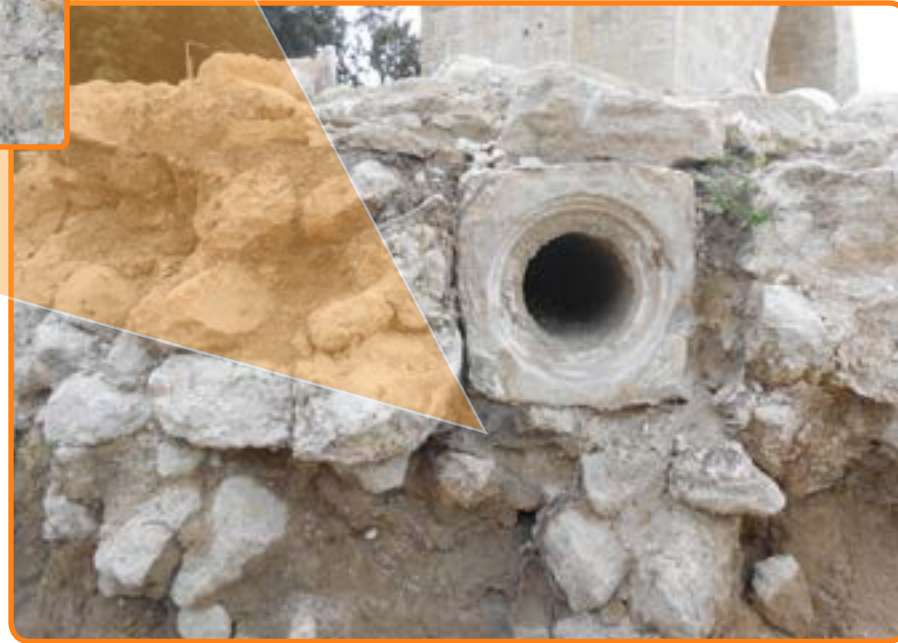
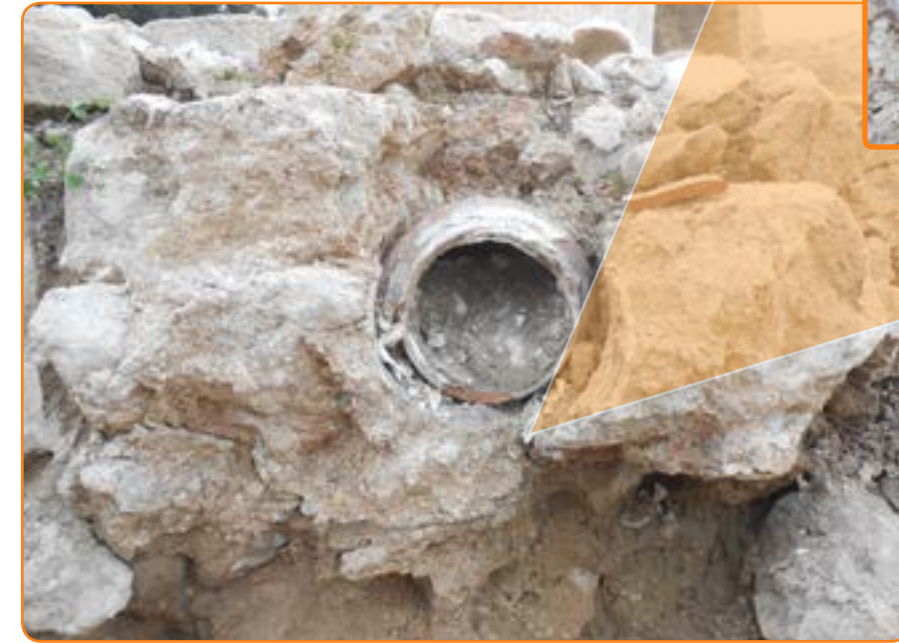
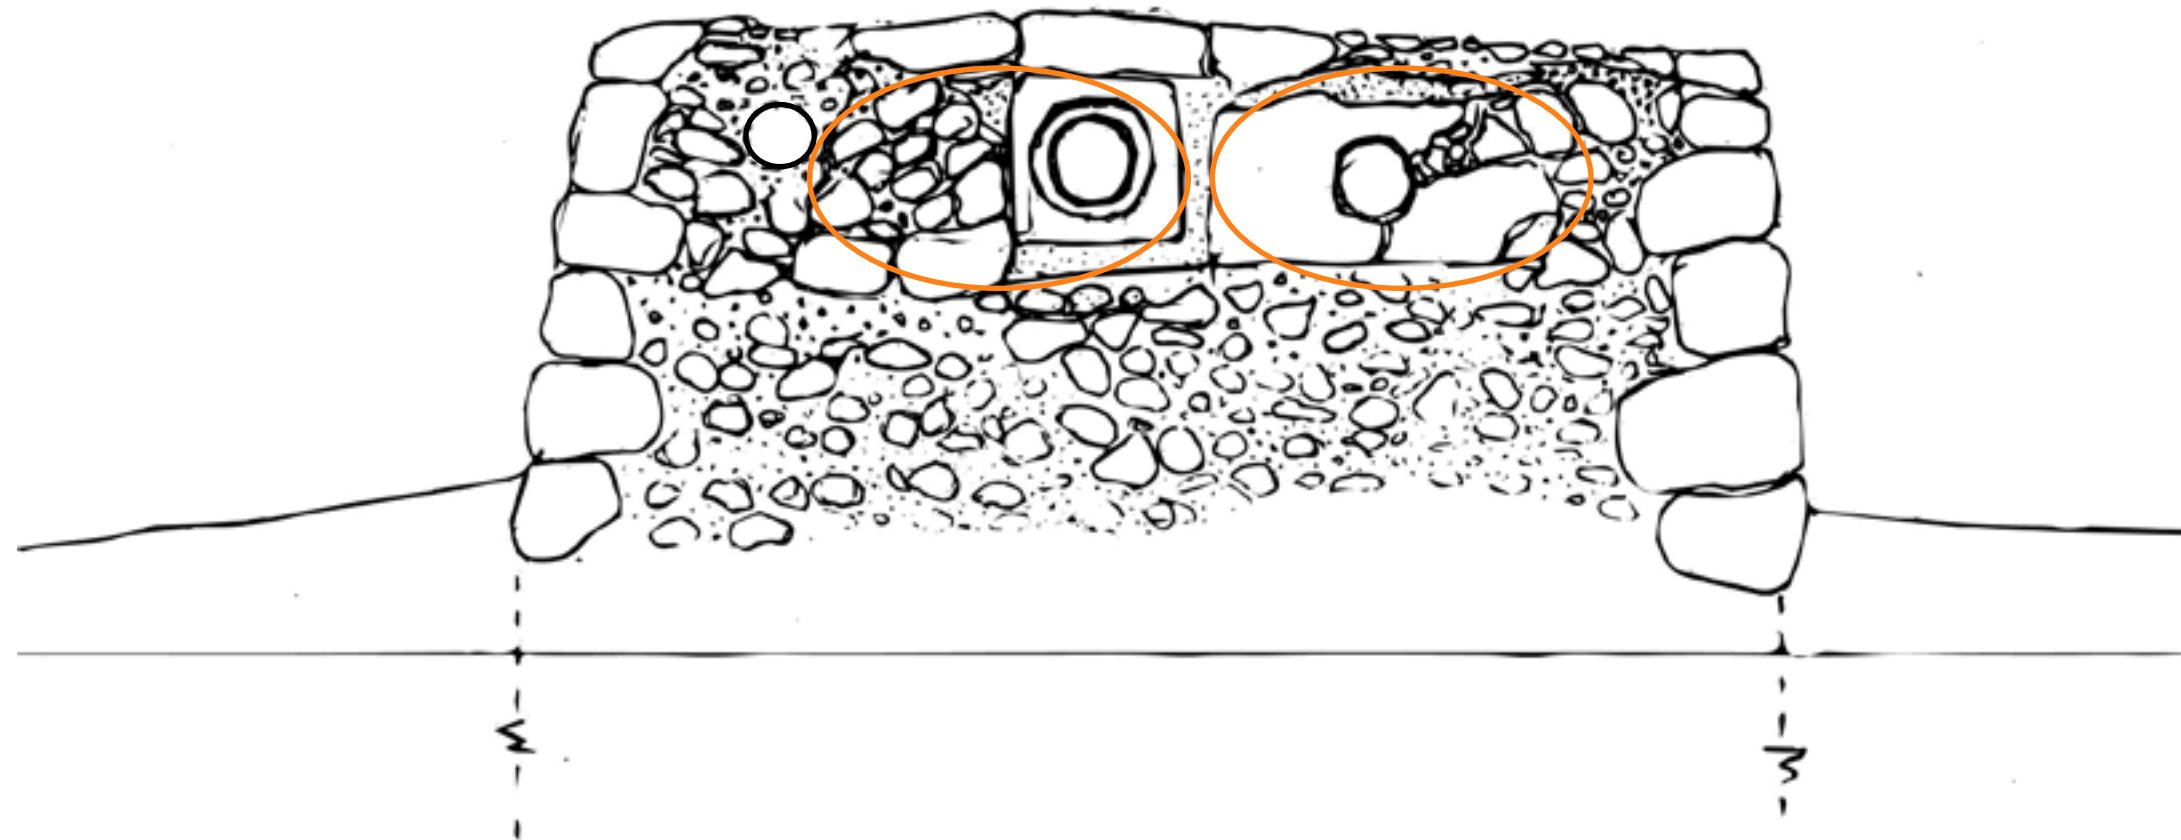
Macro pictures of mortars

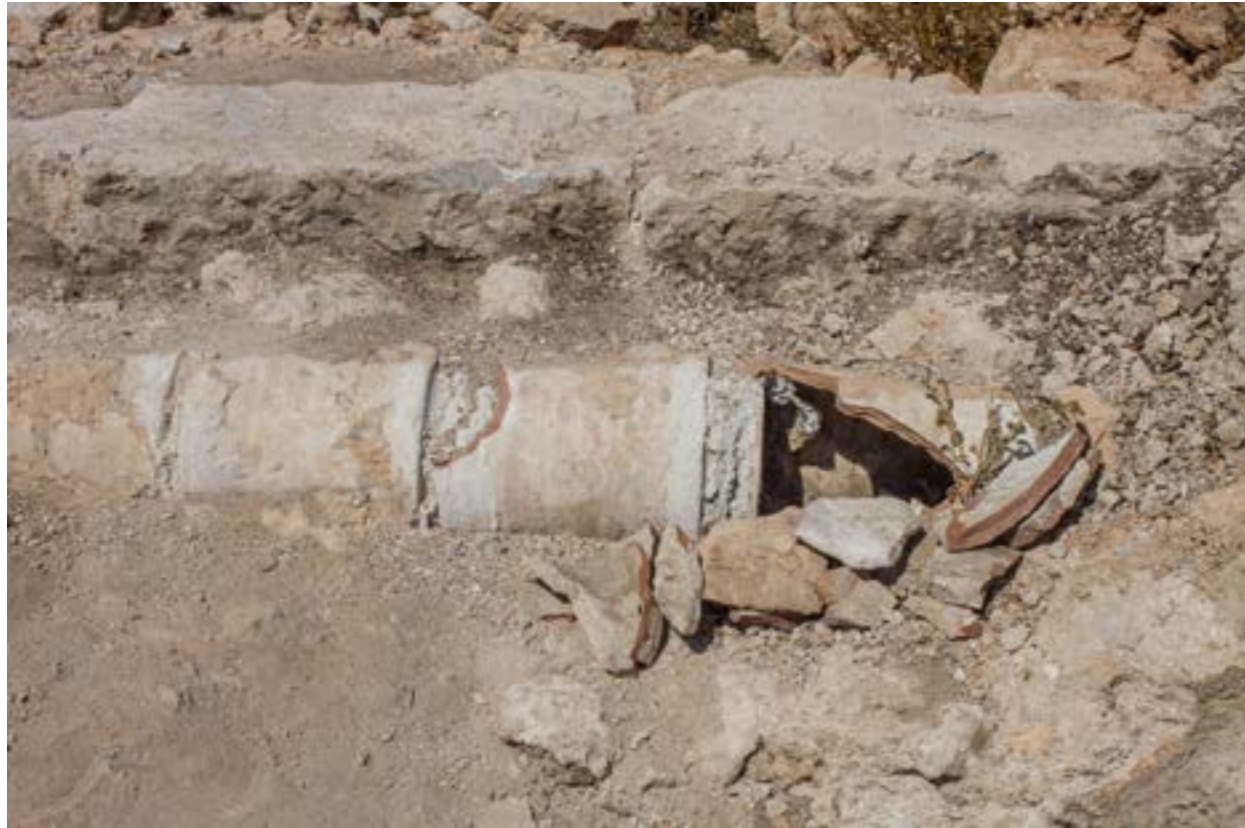
Ceramic pipe, photo

This is an illustration portraying a section of a ceramic pipe as found in the segment of the aqueduct being studied in this project. The pipes were constructed out of ceramic material and linked together with lime mortar. The ceramic pipes found on site were installed before the original stone pipe was put in place. The size of both clay pipes pieces are more or less the same.

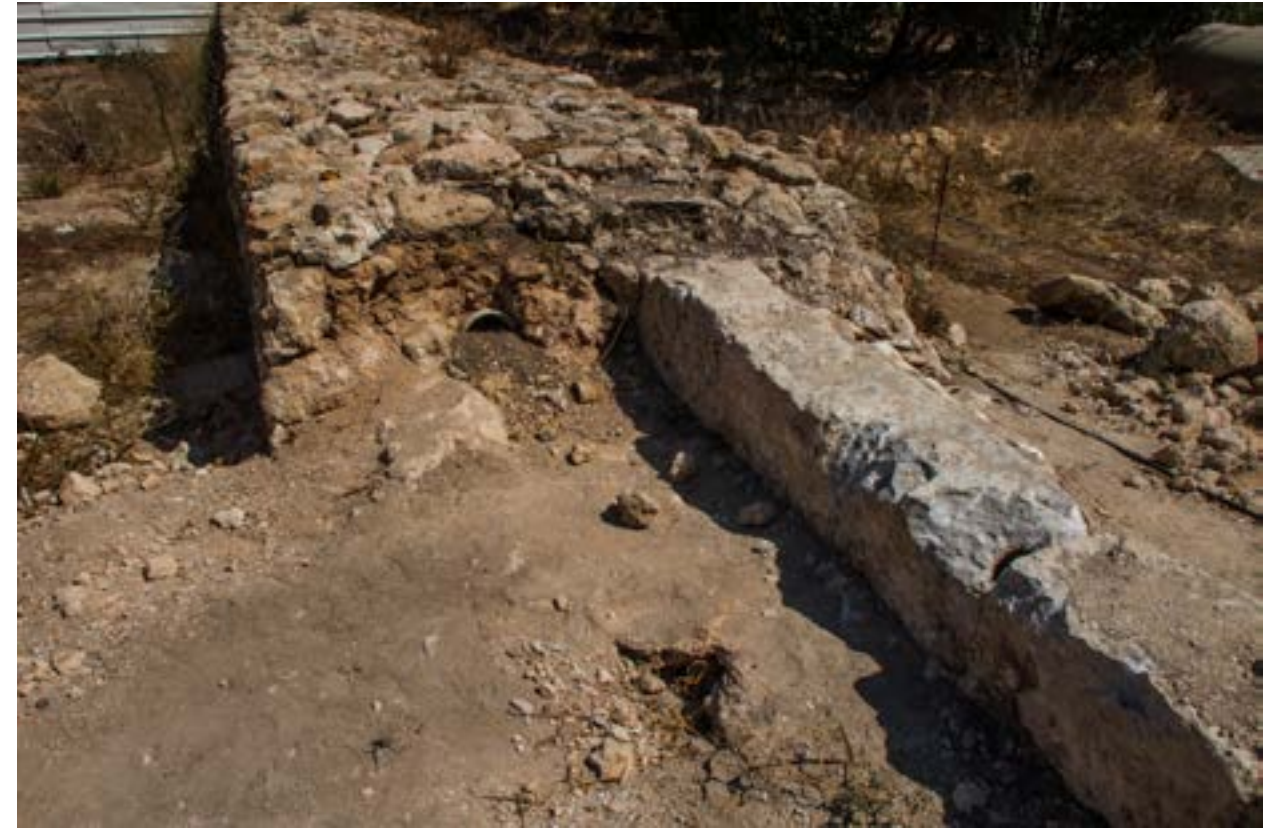
Stone pipe, photo

This is an illustration portraying a section of a stone pipe as found in the segment of the aqueduct being studied in this project. The pipes were constructed out of a durable stone material and linked together with lime mortar. The stone pipes found on site were installed after the ceramic pipes. These pipes functioned as the main method of water transportation from the Kabri spring to Akko.

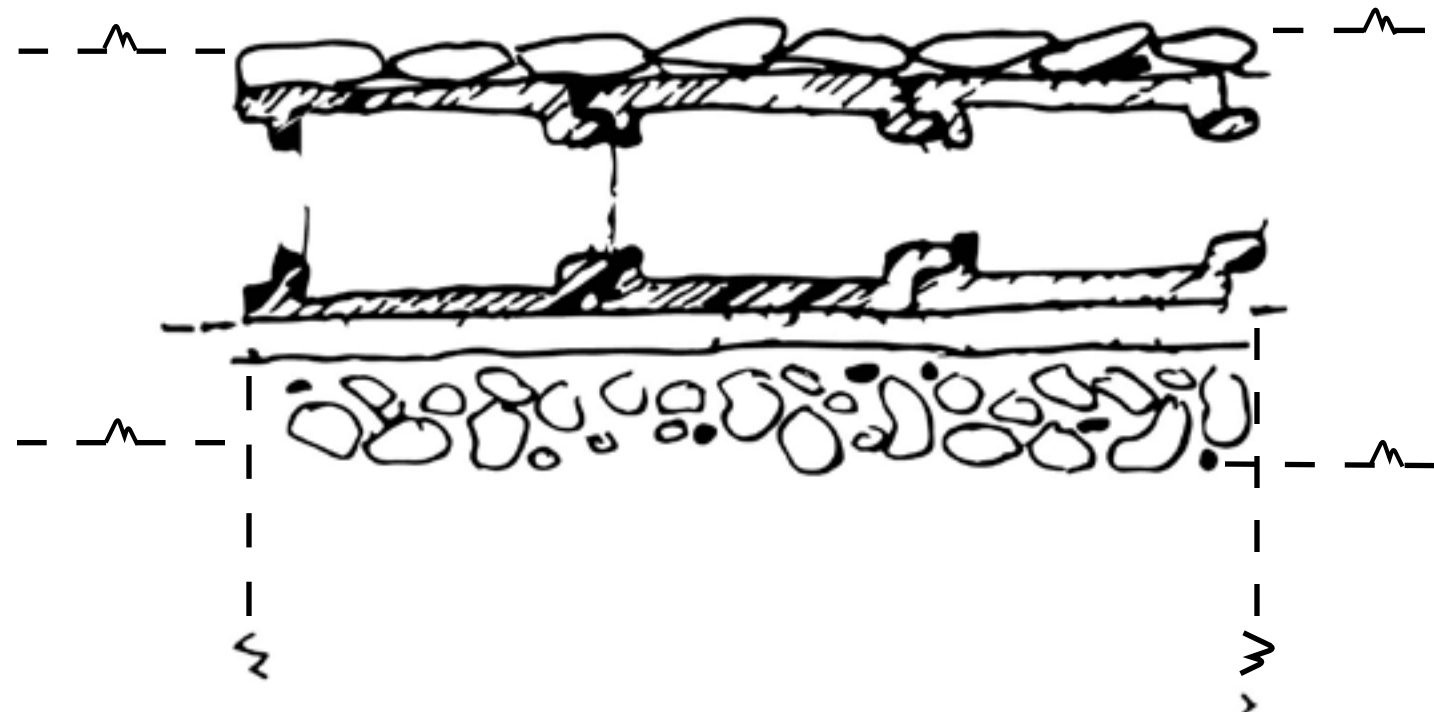
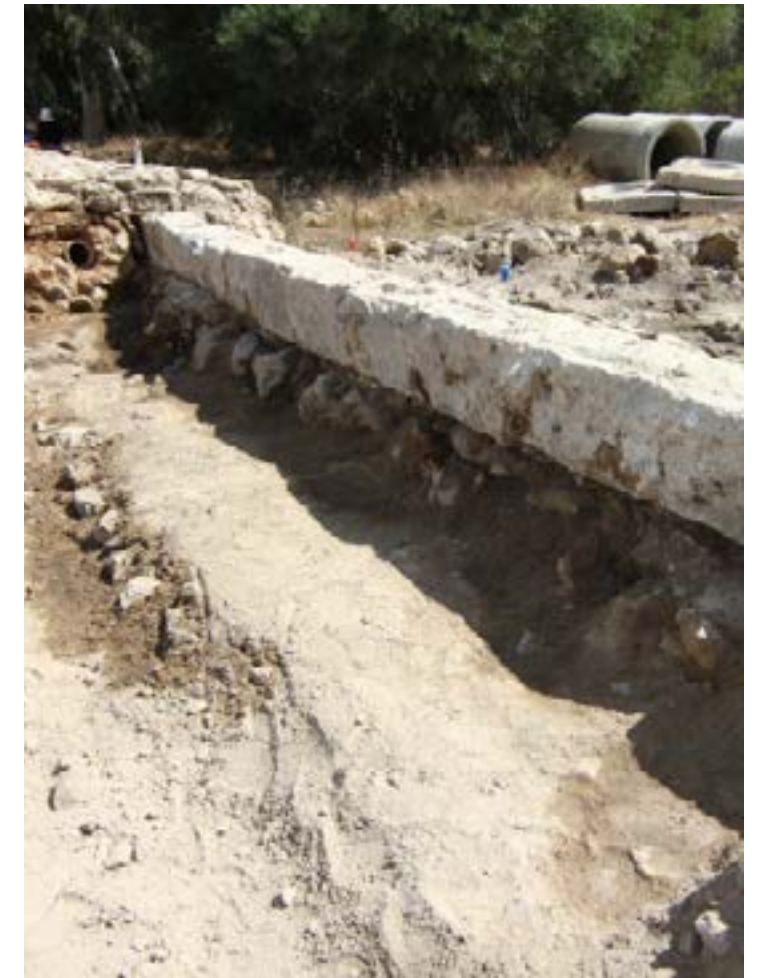
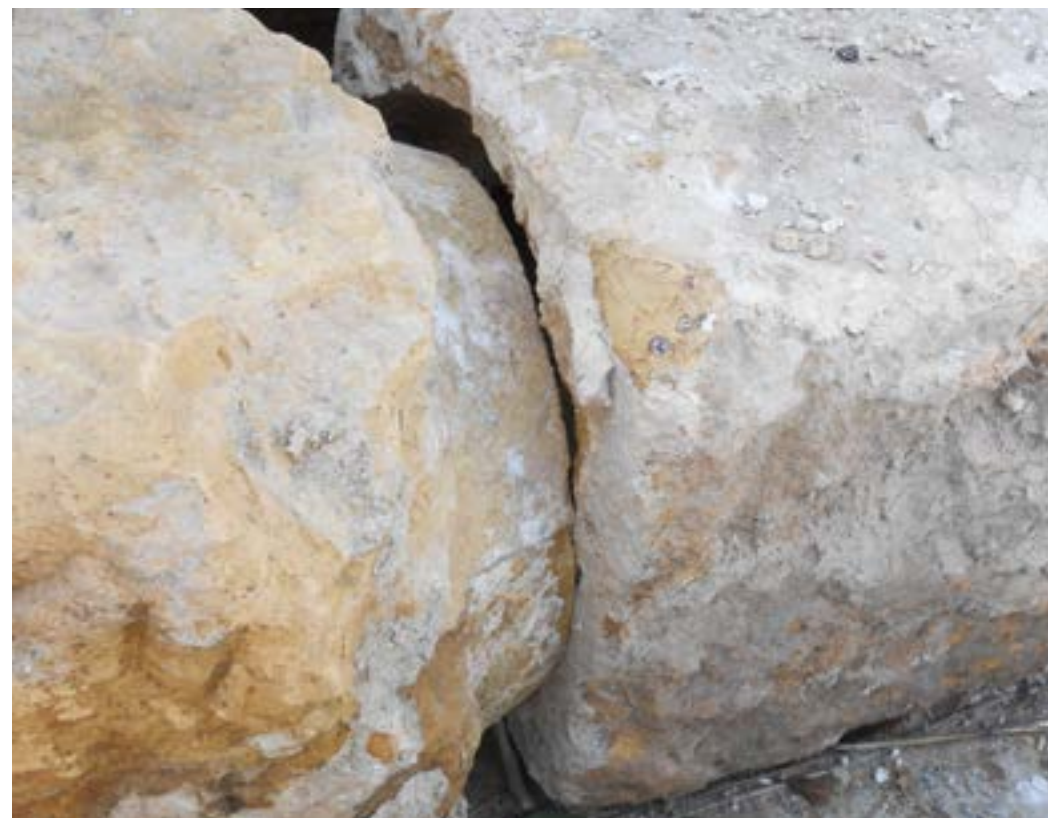
Stone pipe section drawing:

Between each part of the pipe there is a very thin layer of hydraulic limestone

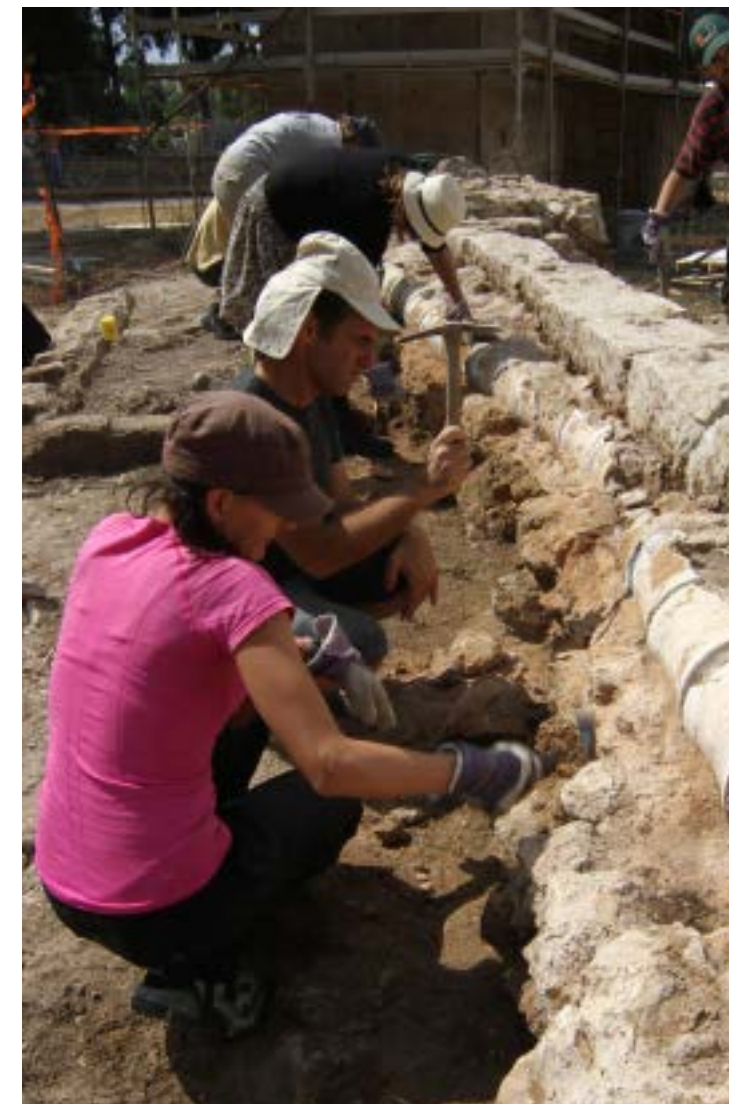
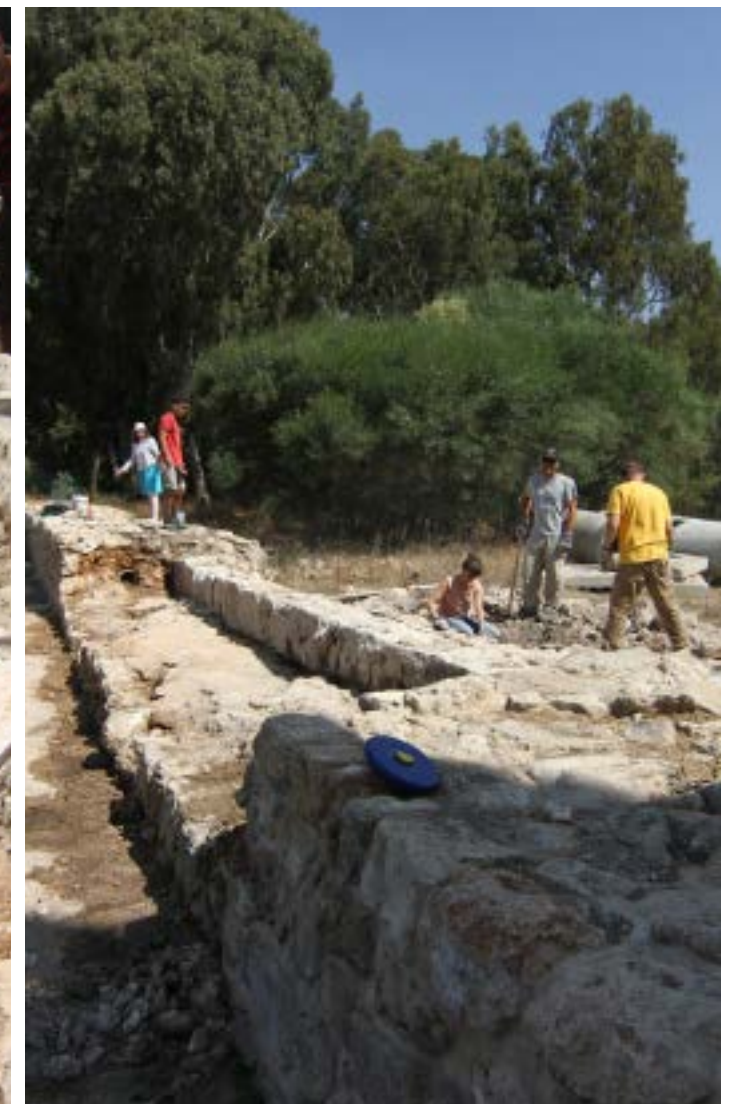
Pictures of the cleaning process

Preperation for Disassembly	
Site Analysis	<ul style="list-style-type: none"> • Before any work could be done, it was necessary that the leaders of the disassembly project (Rob Kesack and Nikos Monsein Yurss) make several visits to the location to assess the condition and status of the site.
Initial Documentation	<ul style="list-style-type: none"> • Measurements were taken in situ and, from there, everything was documented quite meticulously. • Documentation of the site was done via numerous methods to ensure that the highest practical level of detail was recorded. • Methods of documentation used were: rough sketches, detailed architectural drawings and plans, photographs, 3D models produced and rendered via a photogrammetric procedure, and finally this report in which all results and findings have been compiled.
Determing the Necessary Tools	<ul style="list-style-type: none"> • Upon analysis of the observations made during the initial visits, it was determined that certain tools would be necessary to commence with and complete the disassembly of the aqueduct section. • From these visits, it was determined that a delicate and non-electro-mechanical method would best suit the needs of this project. • At least initially, only basic hand tools were to be used to accomplish the task. • The tools assembled and used on site were as follows: Various sizes of chizels, hammers, small and large picks, pick axes, brushes and brooms for cleaning of the stones and surrounding area, shovels and hoes for the removal of large quantities of dirt and rubble which covered the portion of the aqueduct to be worked on, a water hose, water bottles, and sprayers for fine cleaning of the stone after the second phase of hand clean-

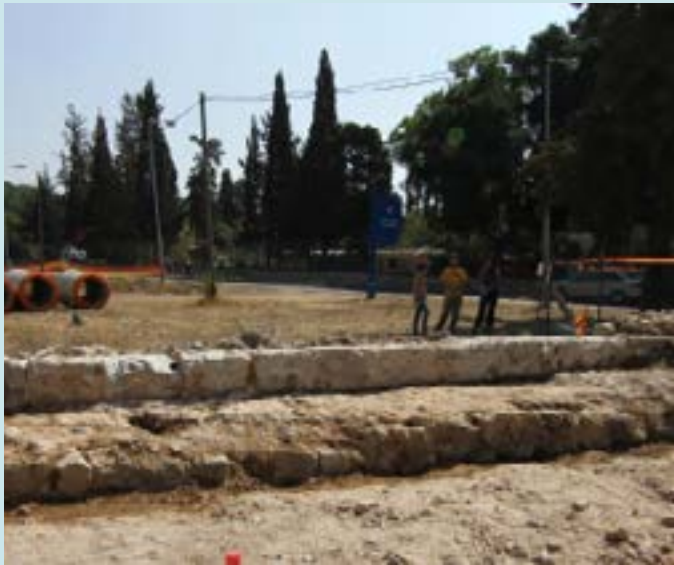
<ul style="list-style-type: none"> The first task at hand for the disassembly crew was to ready the site for the actual disassembly process. To do this, the site needed to be made safe and clean. Phase One of the cleaning process involved the removal of large quantities of dirt and rubble from the immediate area of the aqueduct section in question. Phase Two of the cleaning process was mainly focused on the use of hand tools such as plastic and natural haired brooms and brushes to safely remove the remaining layers of dirt and grime which the shovels and other large tools could not address. Phase Three involved a spray down of water from a hose and pump-action water bottles to remove
<p>Additional Documentation</p>	<ul style="list-style-type: none"> Immediately after the removal of the ceramic pipe, the dismantling of the stone pipe section began. First, an attempt was made to remove the mortar from the extremely narrow, and visually non-existent joints between each stone piece;

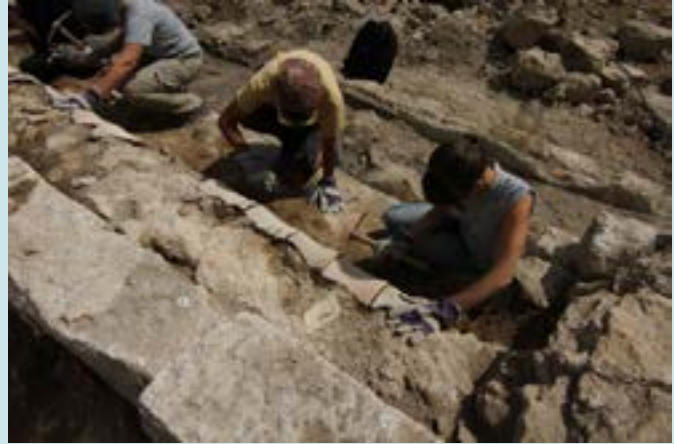
<ul style="list-style-type: none"> The next task was to carefully remove the mortar between the cermaic pipe sections so that they might be freed and removed from their location in situ. The pipes were easily removed by hand with the aid of small and large picks. Each piece along with surrounding smaller fragments were put aside and kept together in one location. (It was not the goal of this project to catalogue and mark numerically these pieces for reassembly, only to remove with caution and preserve the most intact pieces which demonstrate the original construction and technology.)

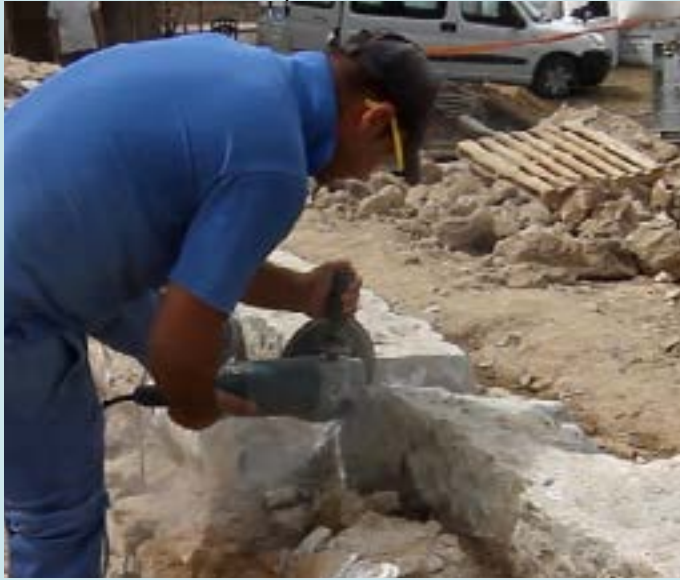
<p>Removal of Stone Pipe</p>

<ul style="list-style-type: none"> Immediately after the removal of the ceramic pipe, the dismantling of the stone pipe section began. First, an attempt was made to remove the mortar from the extremely narrow, and visually non-existent joints between each stone piece; for this, small hand tools such as picks and hammers and chisels were used. weakest stone with the cut and then be able to one-by-one remove the remaining pieces. The hand tools proved inefficient against the strength of construction and integrity of the particular section of pipe. It was decided to incorporate the use of a powered electric Skill saw to cut through the weakest stone in the segment.

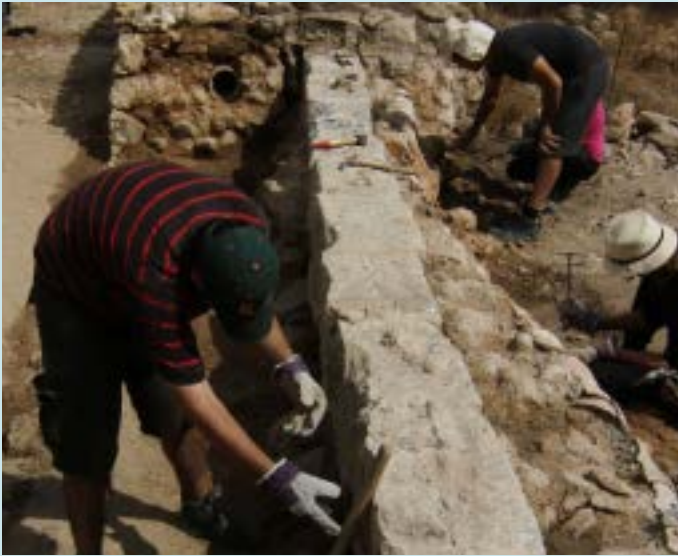
Removal of Stone Pipe (Cont.)

- The idea behind this strategy was to free the weakest stone in the series and then easily remove the remaining pieces of pipe.
- This method too proved non-effective.
- A rear tractor, otherwise known more commonly as a "backhoe", was brought in to the site to aid in the removal of the stubborn stone pipe.
- The tractor also failed to free the stones from the site and work ceased for the rest of the day.
