Technical conservation plan for an architectural detail in the Khan El Faranj

Nika Bogdanić Saving the Stones January 2014

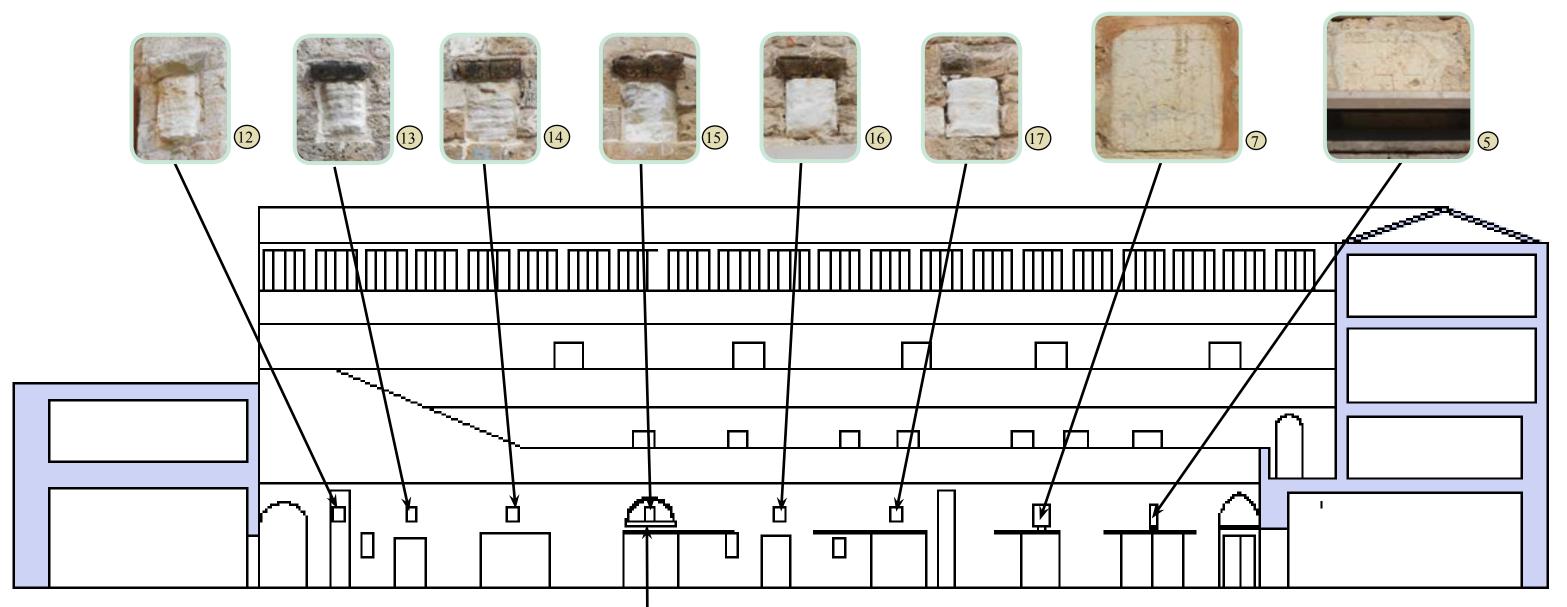
North facade

6 identical pilars set on the same height of the north facade

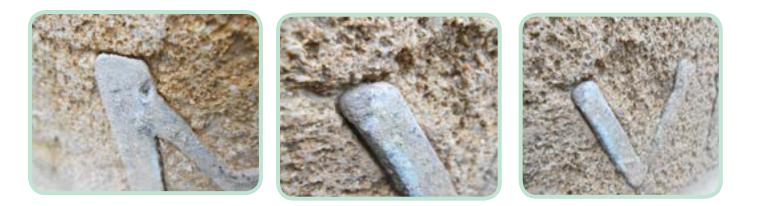
The letters of the inscription

- 1) the sandstone has been carved in the shape of the letter
- 2) hot led has been poured inside of the carving
- 3) the led has expanded after getting cold and it is firmly attached to the sandstone (very strong led, no disattachment problems)

- the time and the weather condition caused corrosion on the led

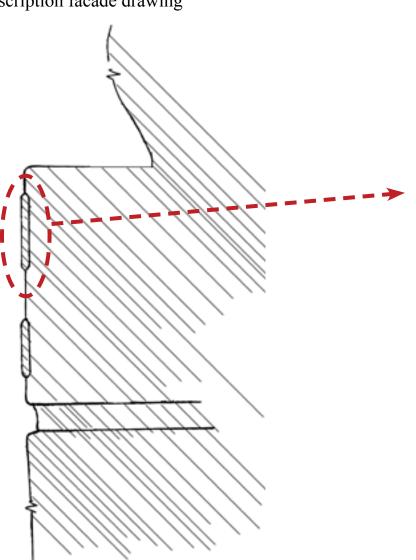
Inscription section drawing

- through a crack on the ledge water comes in and falls down straight to the inscription sansdstone

- the bio attack causes the deterioration of the ledge, which leads to waterr penetrating through it and falling down to the sansdstone
