Documentation of the floor of the main hall, 2nd Story, The International Conservation Center, Citta' di Roma

This project was accomplished within the framework of
Saving the Stones, Practical Conservation Program
February 2011 - July 2011
Akko, Israel

Abstract

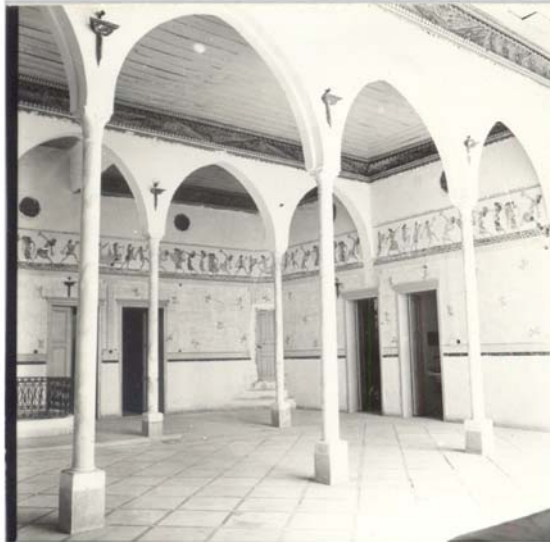
Historic picture of the second story from the 1970's (found in the documentation file of the building)

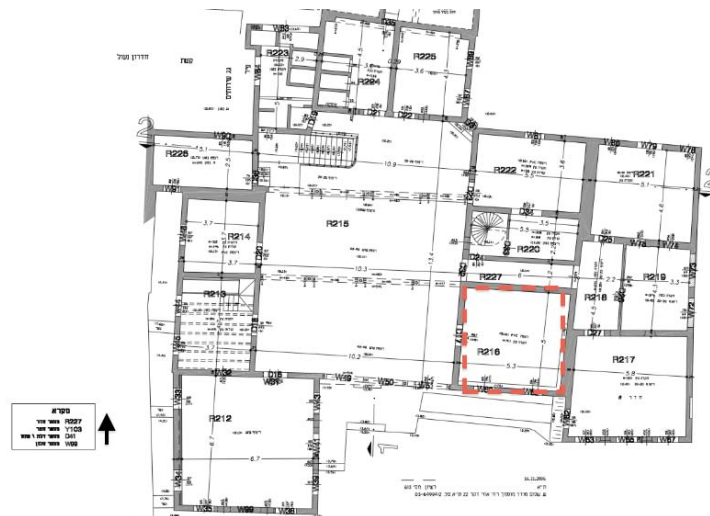
The missing tile pieces are held in storage in the in the next room.

Plan of the second story - the storage space in discussion is indicated in red

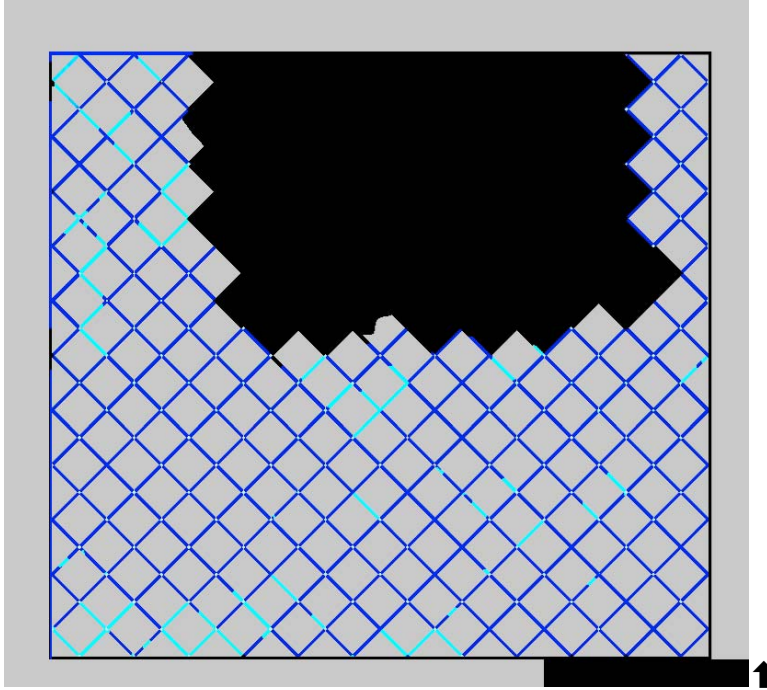
This is a materials map of the floor, as it is current as of this paper.

Marble covers a large section of the floor. The large square pieces, and most of the small square pieces are made of tile. It is gray tile. The large marble tile has a pattern of deterioration that is characterized by cracks. Cracks in the marble are drawn with red lines.

The schist tiles have a pattern of deterioration that is characterized by erosion. The top face of their surfaces flakes off, and this causes the surfaces to dip. It is the inherent vice of the material, as schist is a metamorphic rock, made of layers squished on top of other layers. Some areas of schist are more problematic than others, and only the more problematic schist is indicated on the map by yellow.

Terazzo is a concrete infill, placed on top of eroded schist. Terazzo's surface deteriorates by showing *lacunae*, and the decking/flaking edges. It is a problems that the material exhibits throughout the floor in general. Particularly problematic pieces of terazzo are delineated through the map in purple. There appear to be different kinds of terazzo throughout the floor.

Filling in cracks between the marble. Filling in lacunae in the surface of the terazzo.

Exchange of deteriorating schist for new schist, as needed.

Exchanging deteriorated marble as needed.

Application of a protective coating, to stop or slow the deterioration of the existing schist.
