METHODS AND OBJECTIVES OF THE STRUCTURAL ASSESSMENT OF HISTORIC CONSTRUCTIONS GENERAL ASPECTS AND CASE STUDIES

Speaker: Prof. Eng. Claudio Modena

SEISMIC BEHAVIOR OF MASONRY BUILDINGS

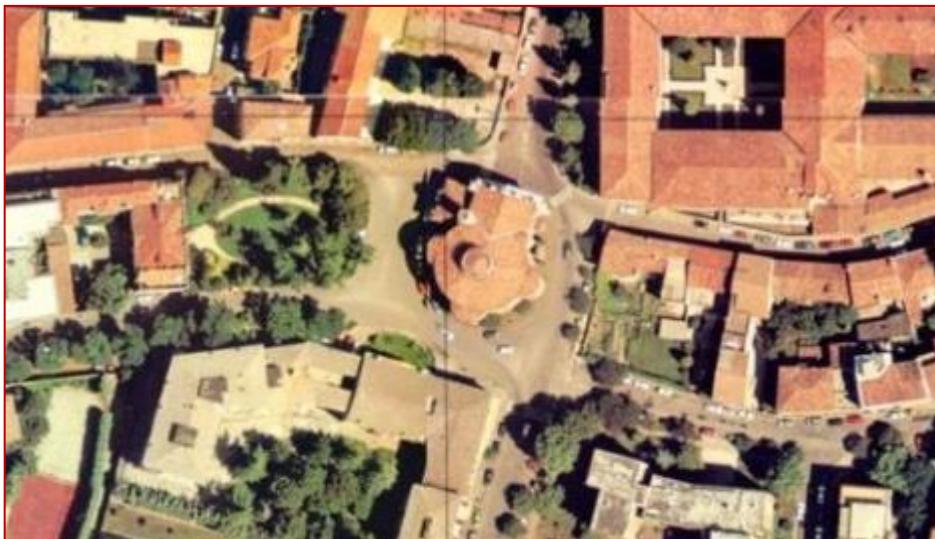
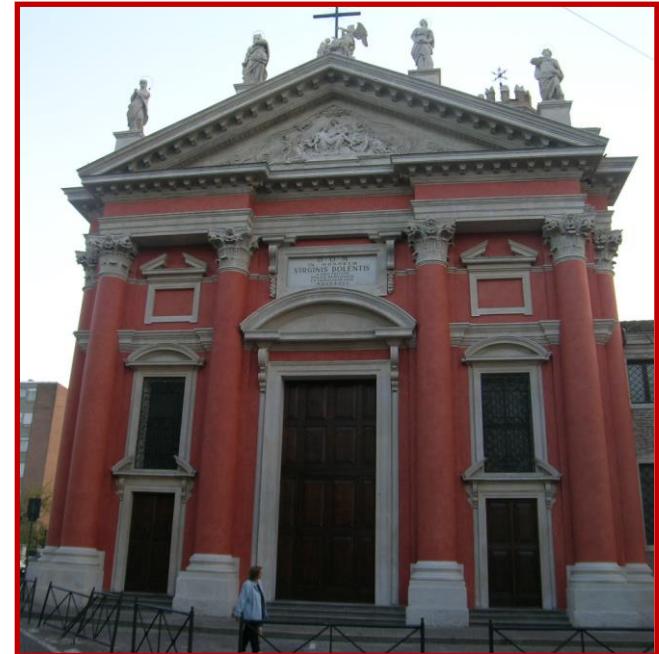
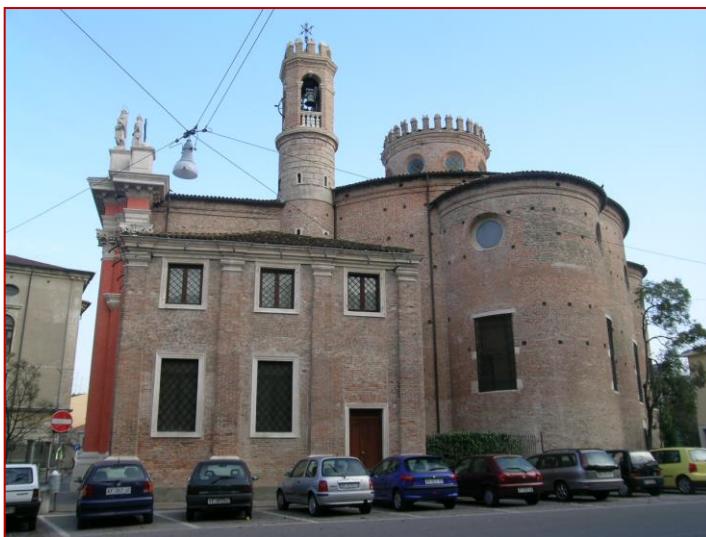
THE CHURCH OF 'MADONNA DEL PIANTO' (Padova)

XVIII Century church by Frigimelica with central plan and some irregularities due to following resets done in the first half of the XX Century

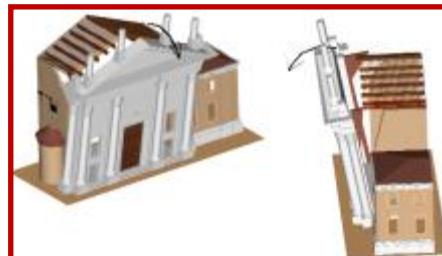
FAÇADE

POSSIBLE AND PROBABLE COLLAPSE MECHANISMS

$$M_{st1} = 52230 \text{ daNm}$$

$$M_{inst1} = 3984900 \text{ daNm}$$

$$\lambda_1 = 0,0131$$

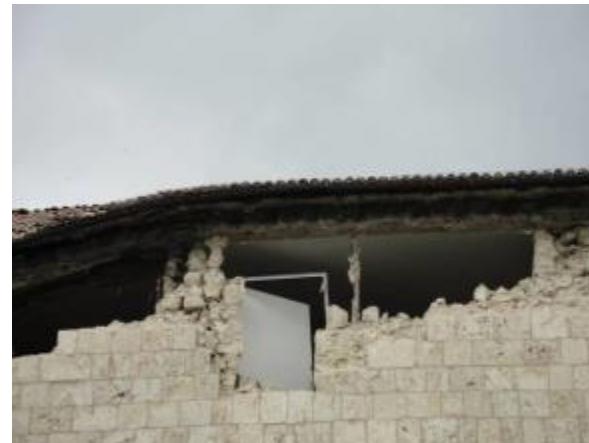
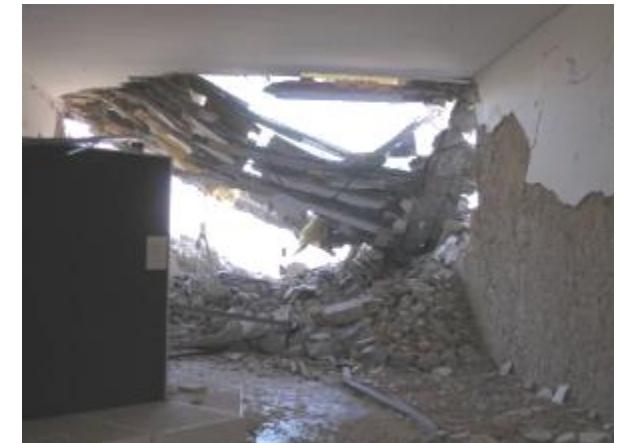
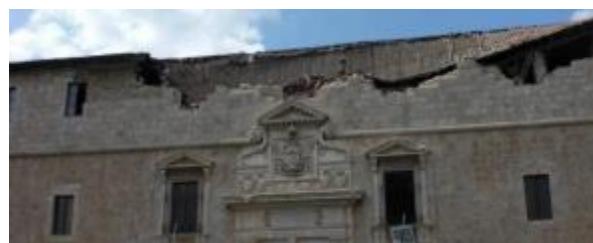
Cattiva qualità della muratura e cattivo ammorsamento tra pareti. Rivestimento esterno in travertino.

Presenza di cordoli in c.a. e solai in latero-cemento, hanno portato ad un appesantimento ed martellamento della muratura

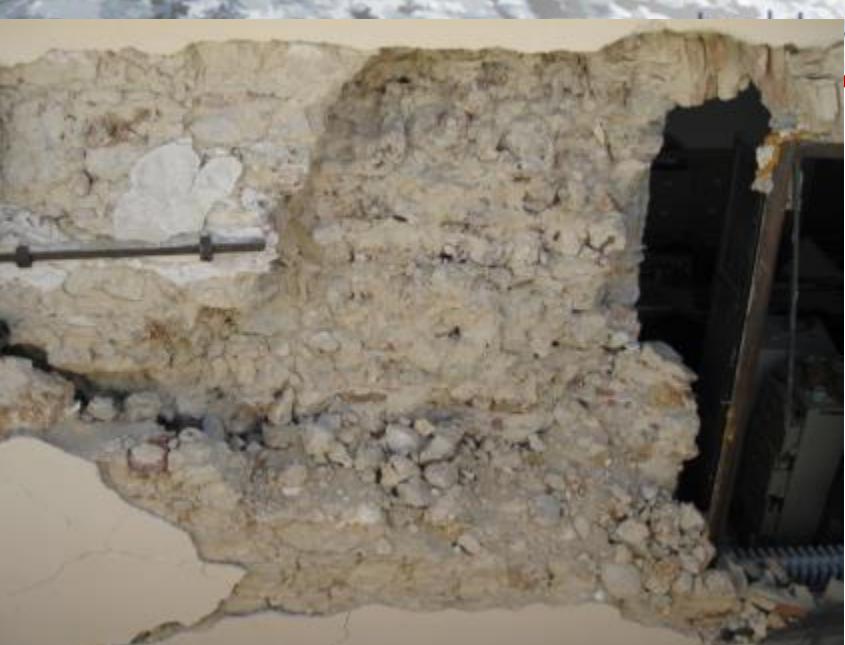
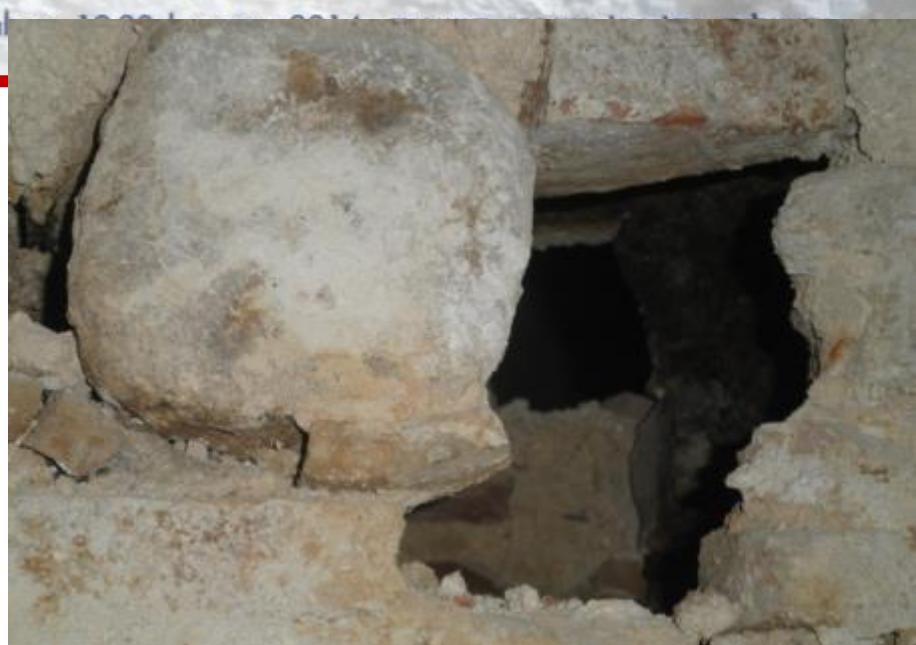
Caratteristiche scadenti delle murature

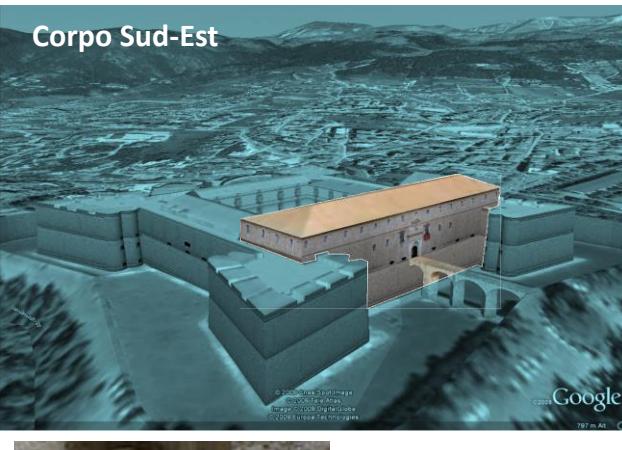
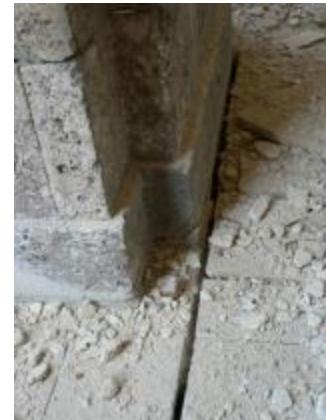
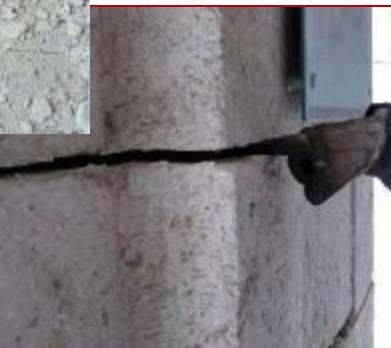
Corpo Sud-Est

Ribaltamento del loggiato e dei piloni del piano terra

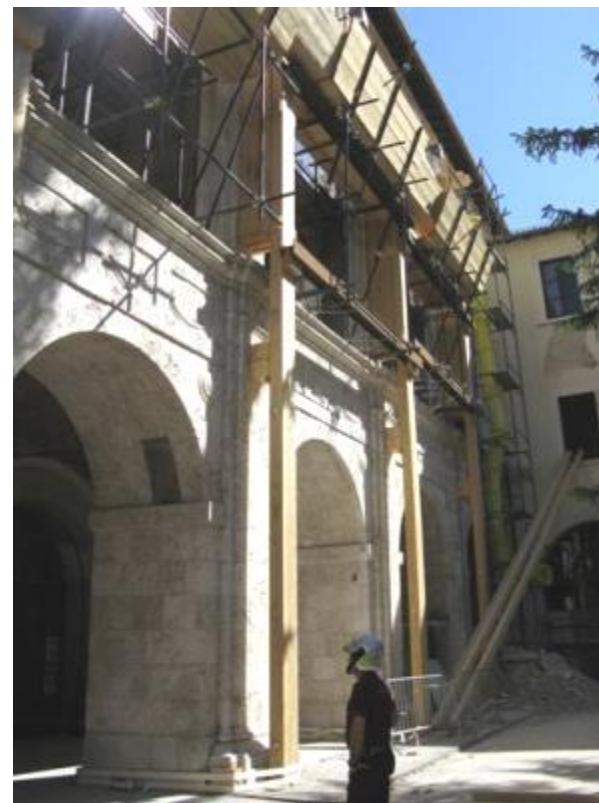
Il porticato a doppia loggia. Individuazione della lesione.

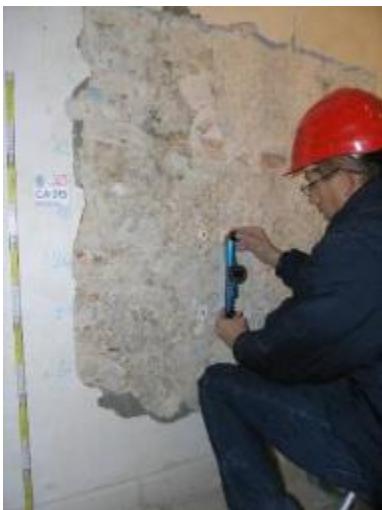
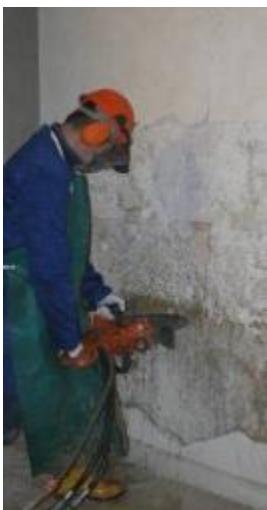
Point 1

State of stress

2.47 N/mm²

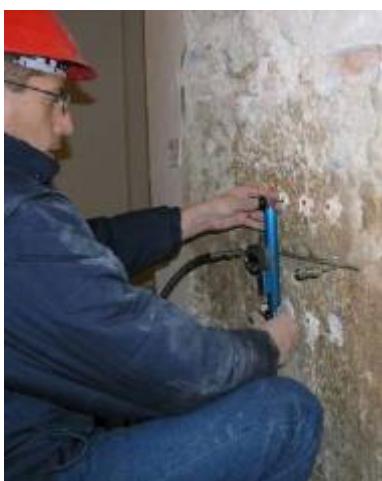
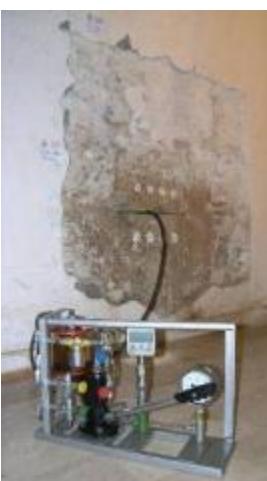
Point 2

State of stress

1.82 N/mm²

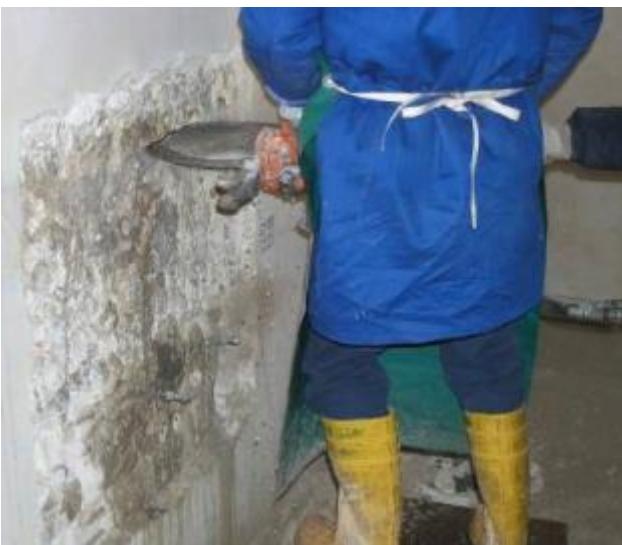
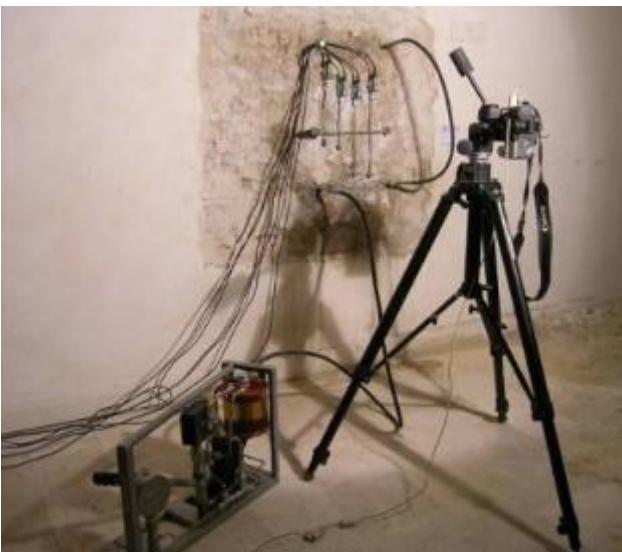
MARTINETTI PIATTI DOPPI

Martinetto piatto doppio – CA-J3D

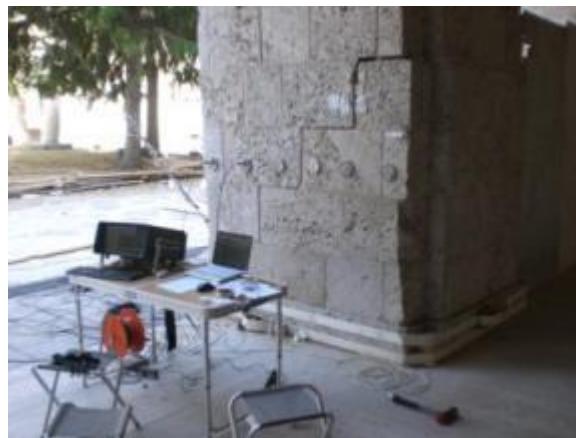
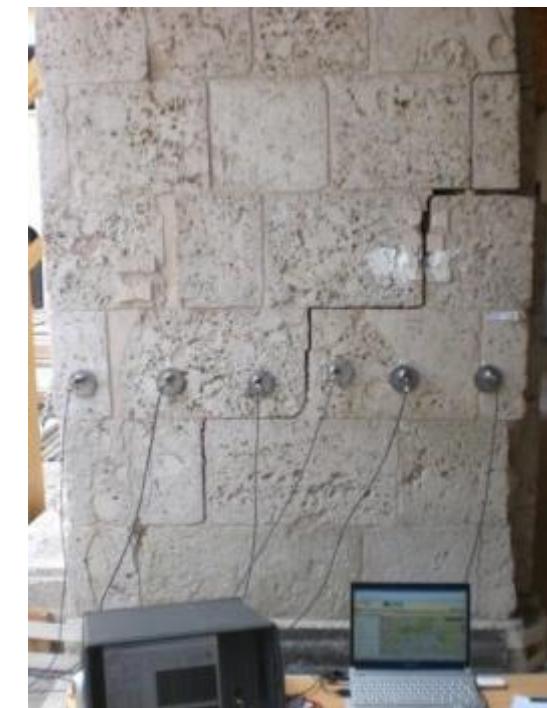
TOMOGRAFIE SONICHE

Le prove soniche sono state eseguite su due pilastri della fortezza: uno danneggiato dal terremoto, l'altro invece intatto.

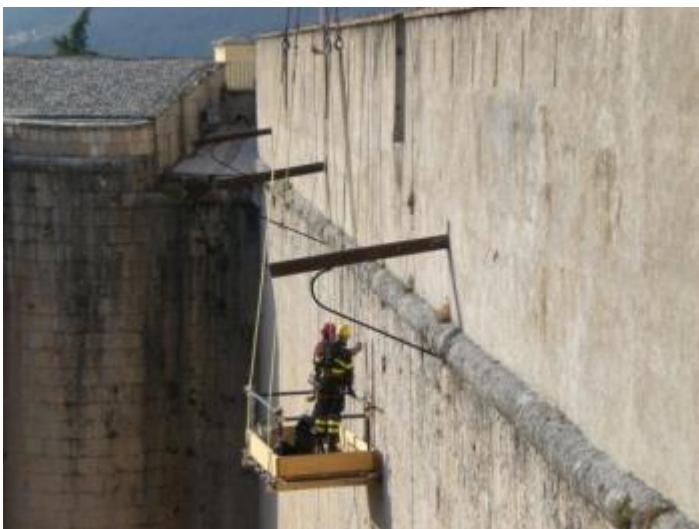
TOMO 1

La tomografia della parete spessa mostra una distribuzione omogenea delle velocità soniche attraverso lo spessore. La muratura, anche all'interno del muro, è di buona qualità

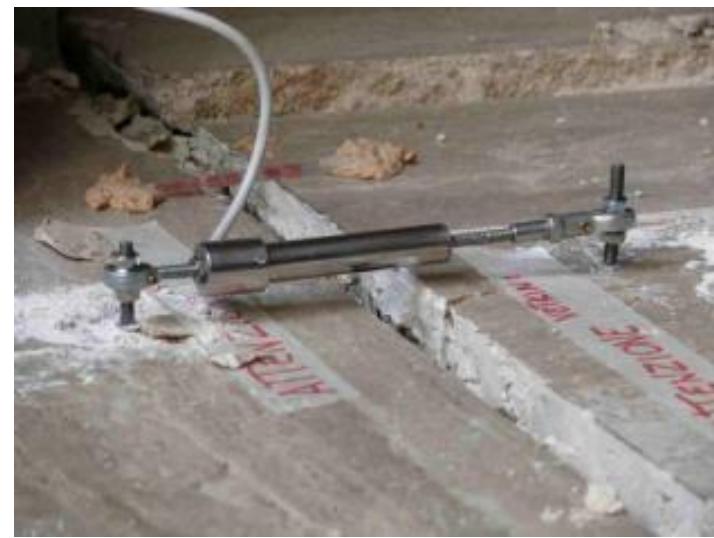
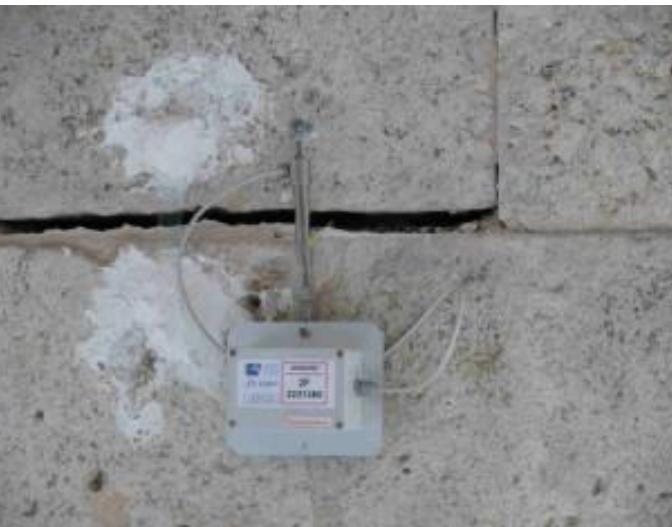
Maggio 2009 rappresentazione delle magnitudo (IGNV) e i rilevamenti dei fessurimetri il giorno 15 maggio Sono stati applicati i tiranti e si giustifica il salto (chiusura della fessura).

Maggio 2009 rappresentazione delle magnitudo (IGNV) e i rilevamenti dei fessurimetri. Il mese è suddiviso due momenti prima dei tiranti. (06-15/05)

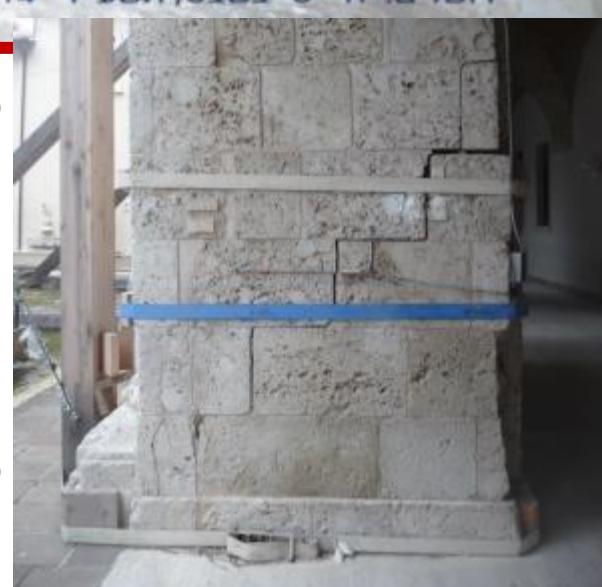
FASE 2

corrente
di carico

posizionamento tiranti

iniezione con malte antiritiro
a base di calce idraulica

Il progetto di recupero dei pilastri
prevede il taglio alla base degli stessi
per «ri-centrare» il carico,
attualmente eccentrico a causa del
meccanismo di ribaltamento della
parete, che ha determinato lo
schiacciamento della base degli stessi.

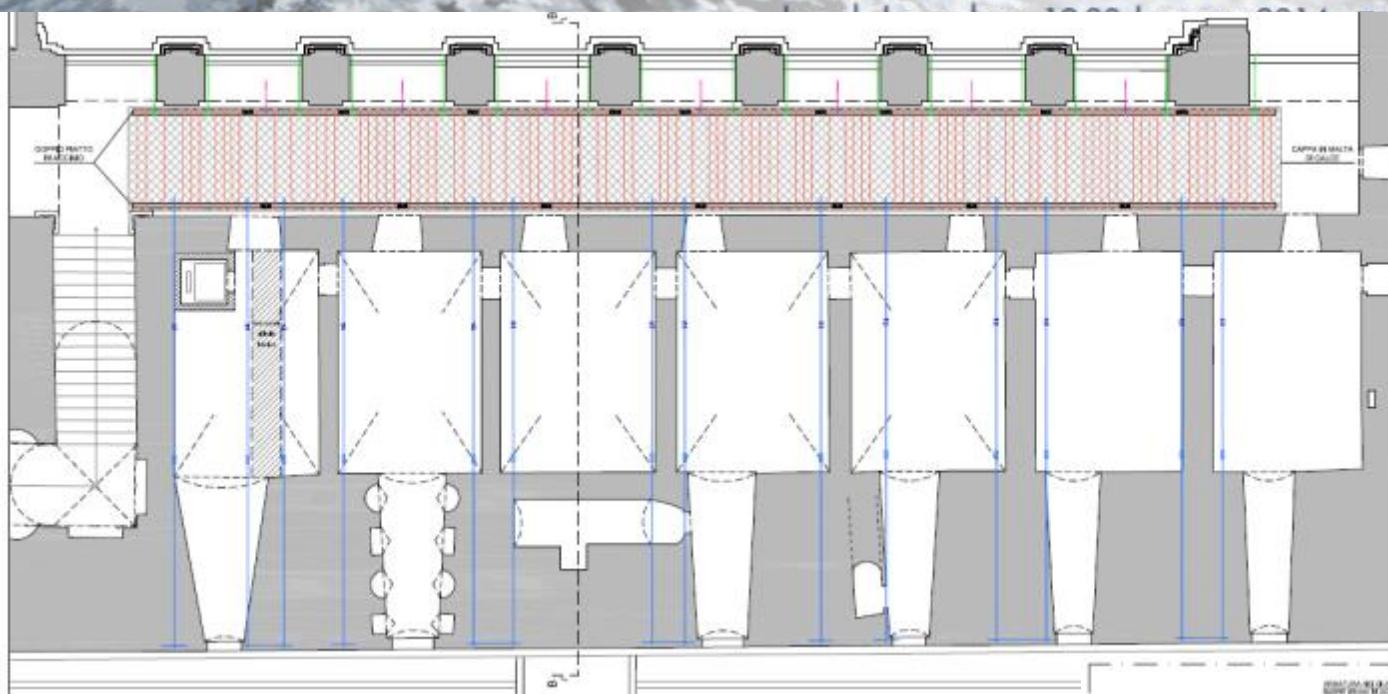
taglio con lama
diamantata di piccolo
spessore su giunto
orizzontale

iniezione con malte
antiritiro a base di
calce idraulica

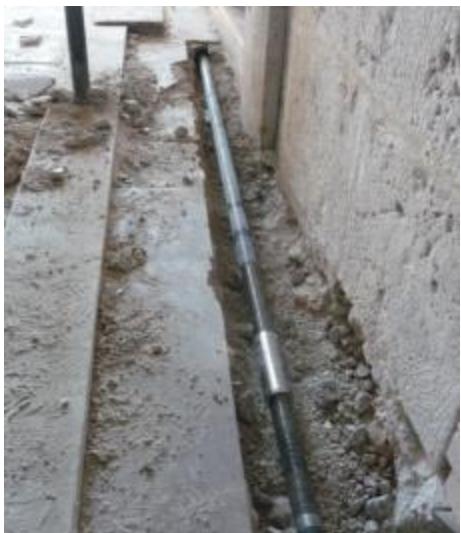
Problematiche rispetto al posizionamento dei tiranti:

- Assenza di allineamento tra setti murari e pilastri
- Limitato spessore tra pavimento e estradosso della volta

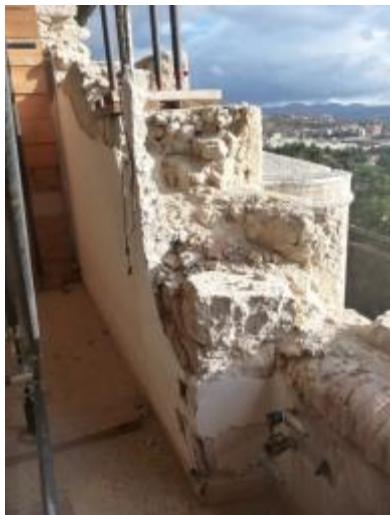
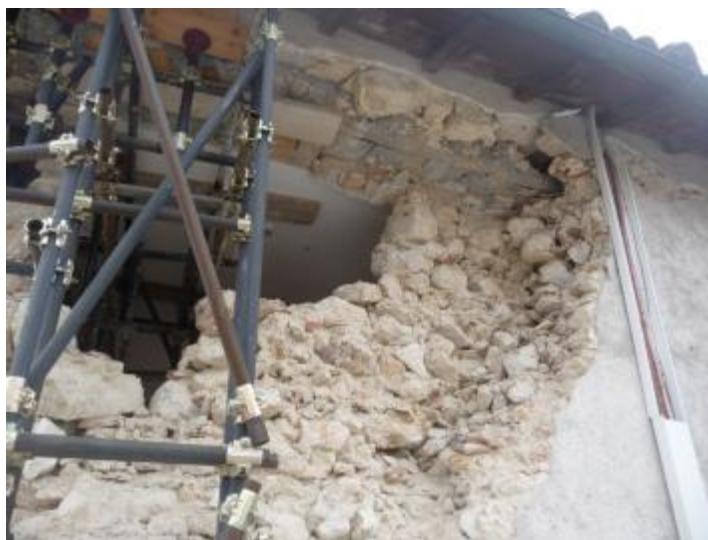
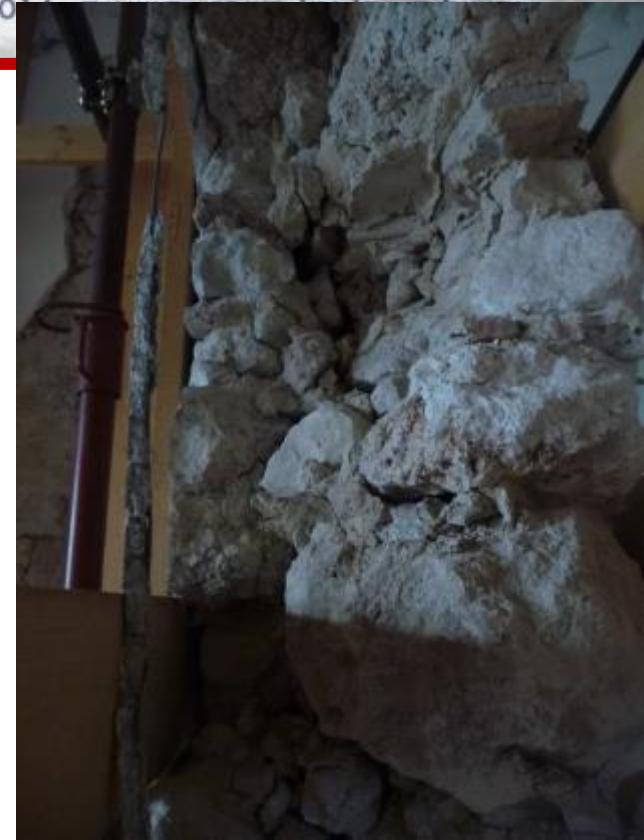
PROGETTO DI RICOSTRUZIONE:
utilizzo di ricorsi in mattoni con armature inserite nei giunti

Tra le principali problematiche connesse alla ricostruzione di strutture gravemente danneggiate vi è la presenza di murature con caratteristiche meccaniche scarse o addirittura pessime.

Si pone quindi il problema di trovare una tipologia costruttiva che garantisca delle buone proprietà meccaniche di resistenza e coesione e al tempo stesso rispetti la tradizione costruttiva originaria.

RICORSO DI MATTONI

ARMATURA NEI GIUNTI -
BARRE Ø6 mm

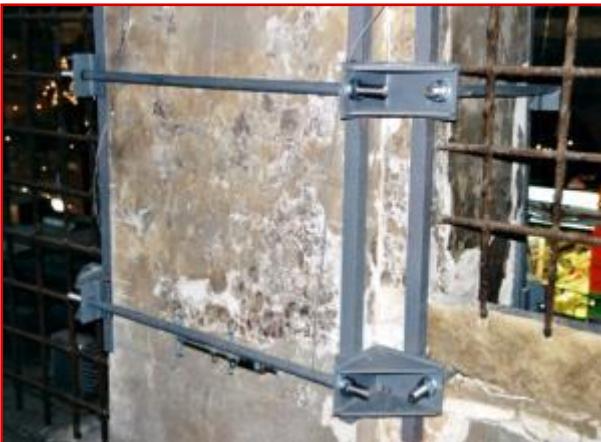
TYING OF A CRACKED PILLAR

Provisional intervention

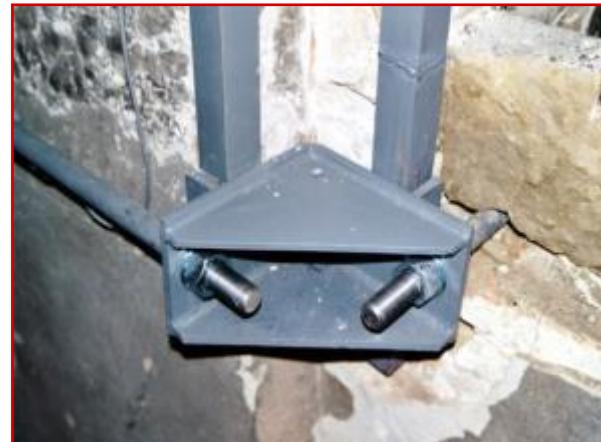
Final intervention

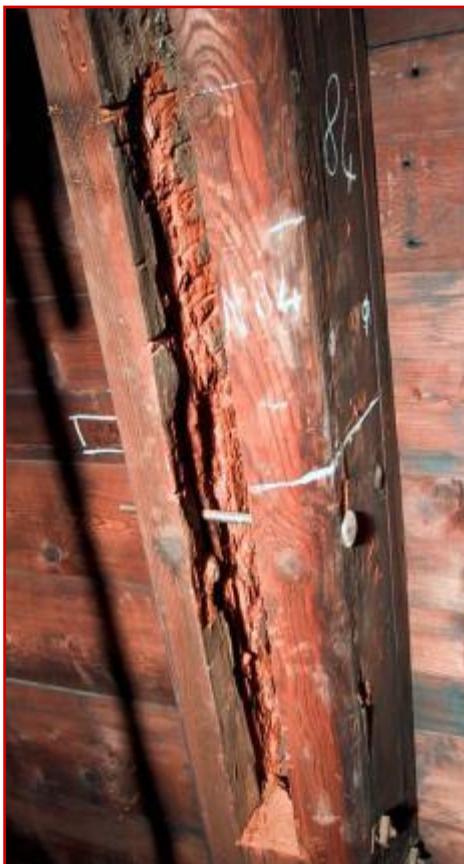
Deterioration of the internal part of a rib

The design of the local repairing was made by taking simple temporary measures allowing for maintaining the stable 3D behaviour and inhibiting local buckling in any phase of the works, by simply limiting the removal (when needed) of the boards forming the shell very locally, in order to permit local repairing, and through simple lateral supports.

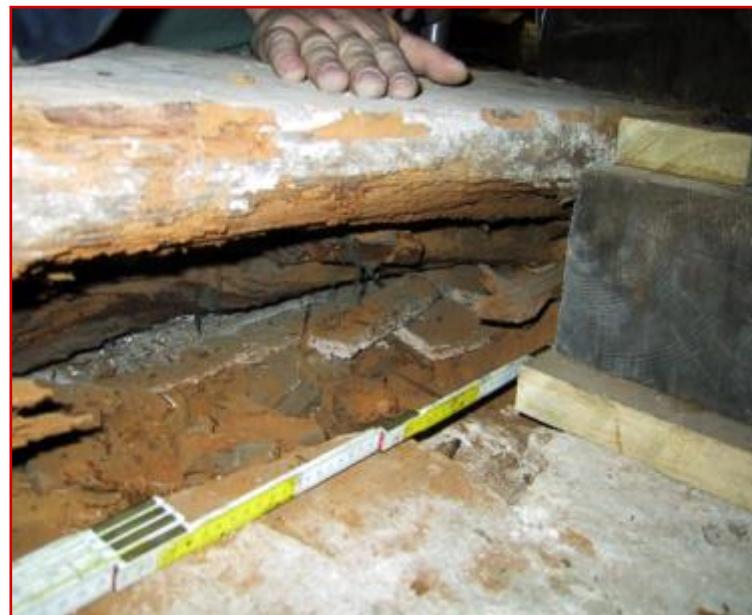
Deterioration of a shelf

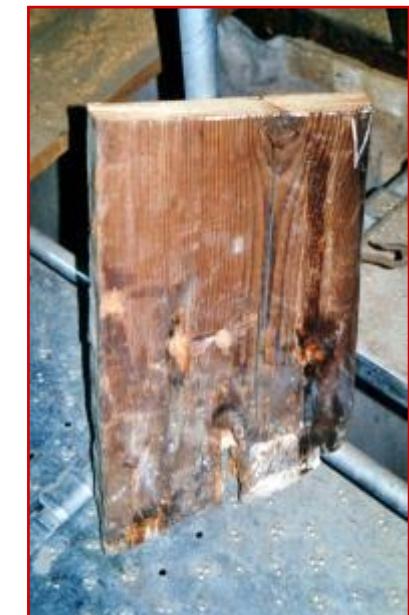
Affected top of a rib

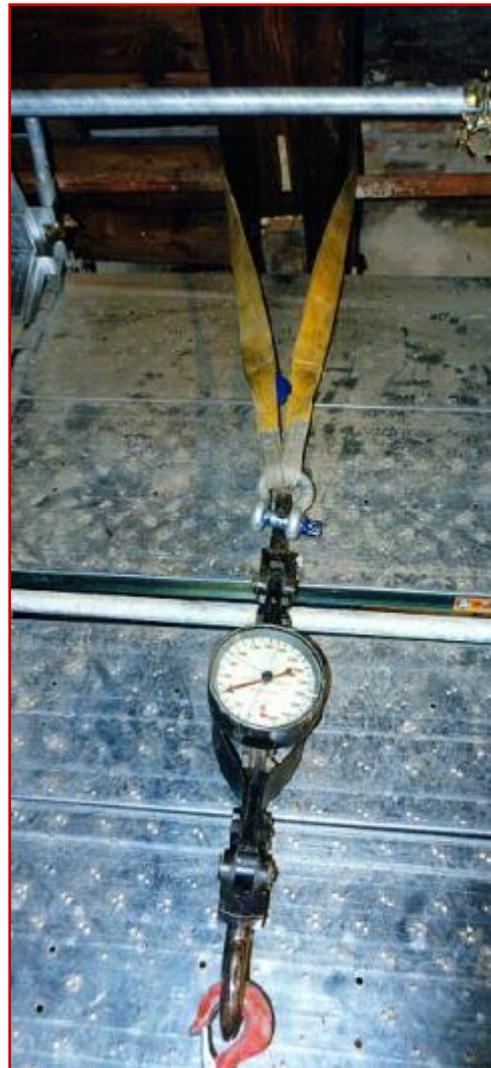
2) insertion of a temporary steel tie

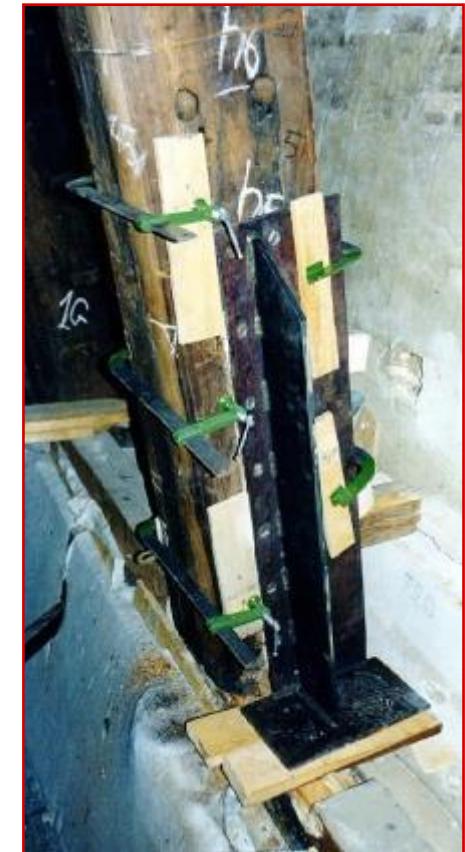
3) carrying out a metallic stirrup

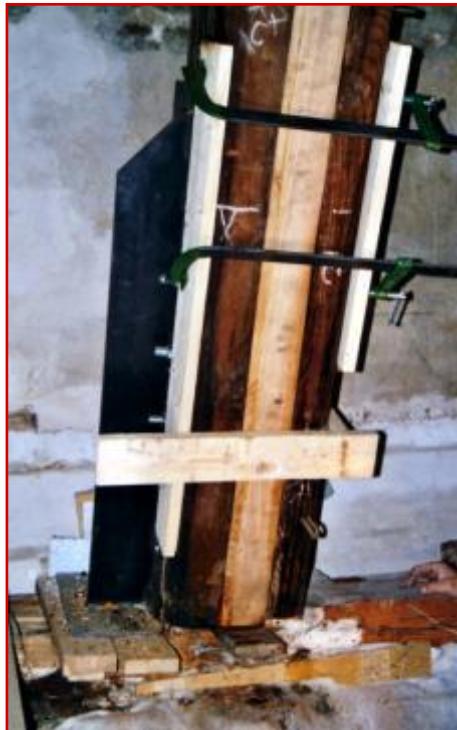
Substitution of degraded elements

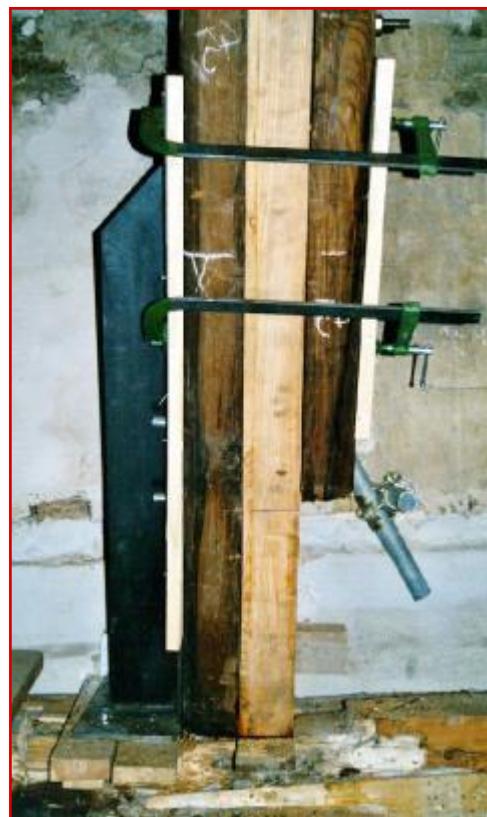
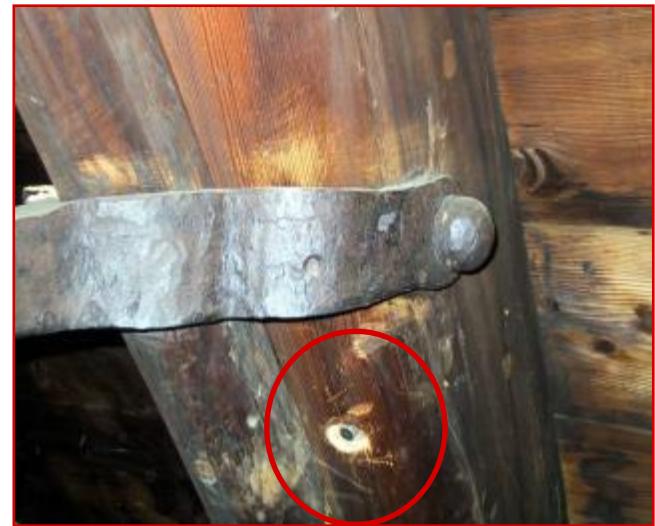
Local stitching of cracks

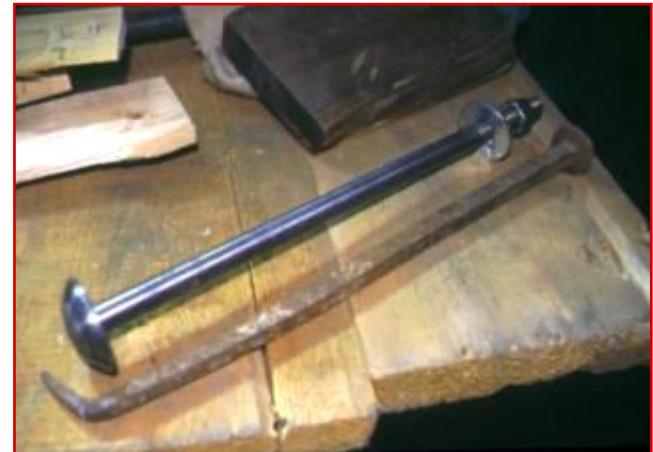
Restoration and integration of the nails

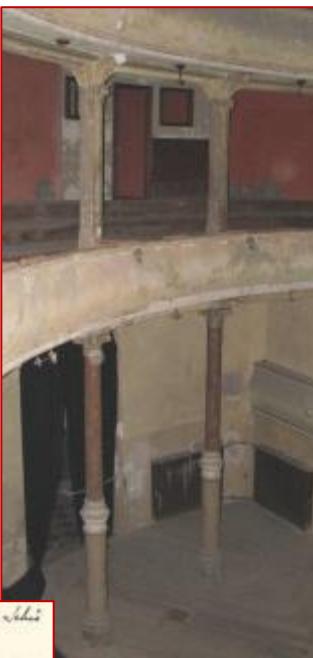
Hennebique system

- foundations:
 - stone, $h \geq 1.50$ m
- vertical structures:
 - masonry walls
 - RC columns → Hennebique system
- horizontal structures:
 - beams and floors → Hennebique system
- roof structures:
 - timber trusses

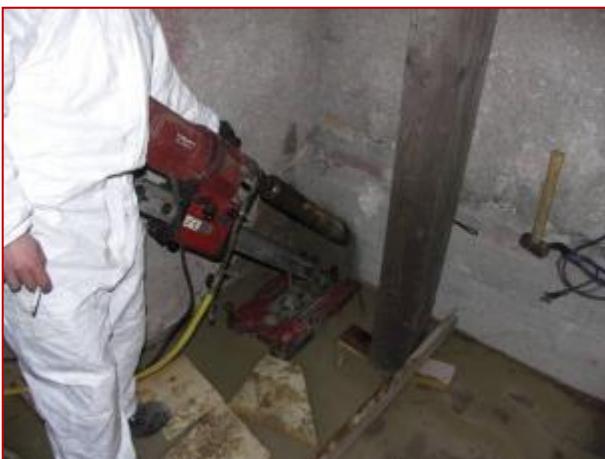
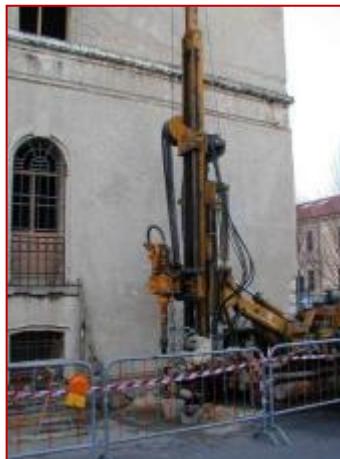
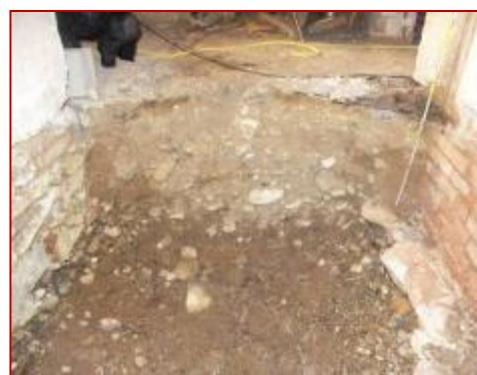
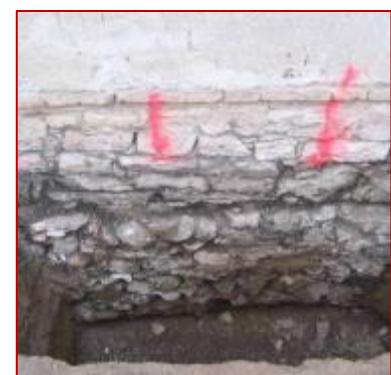
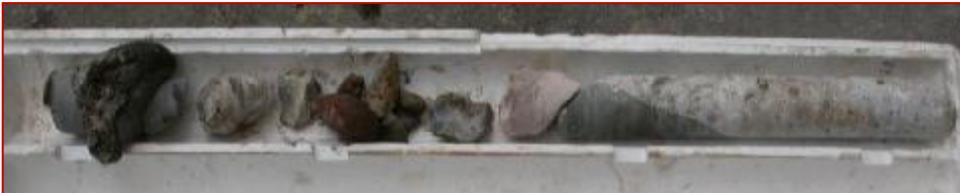
Geotechnical investigations

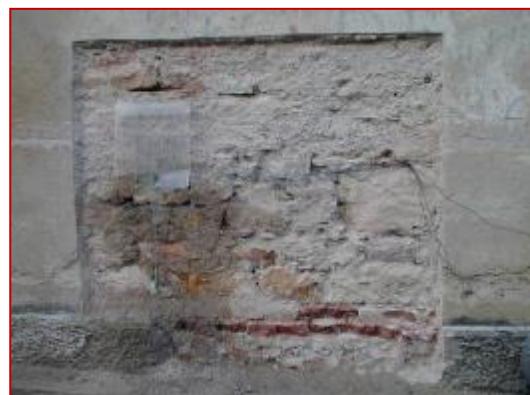
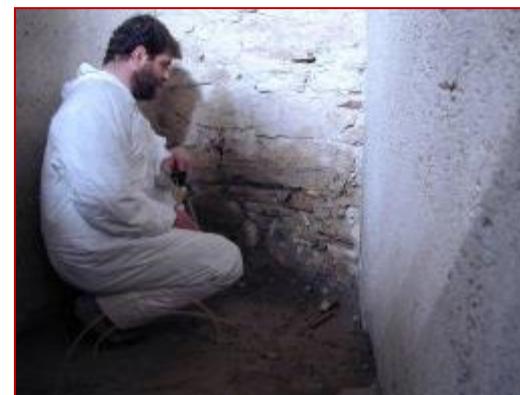
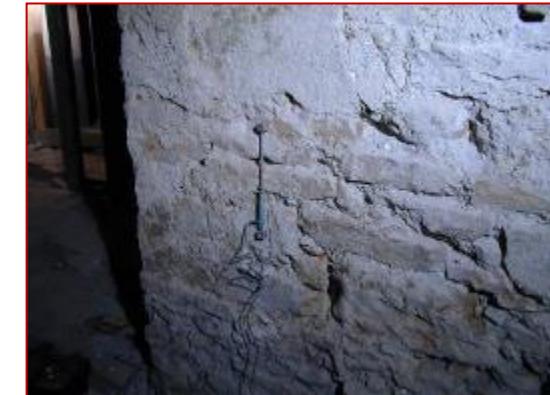
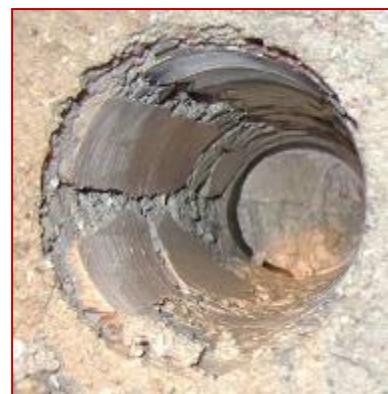
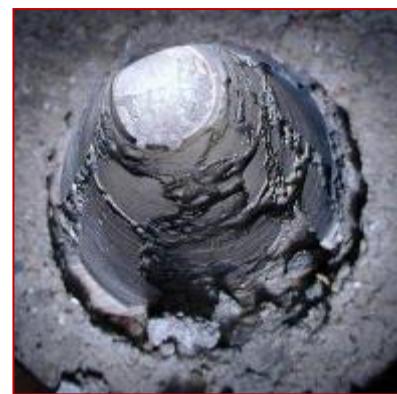
Investigations in situ on masonry walls

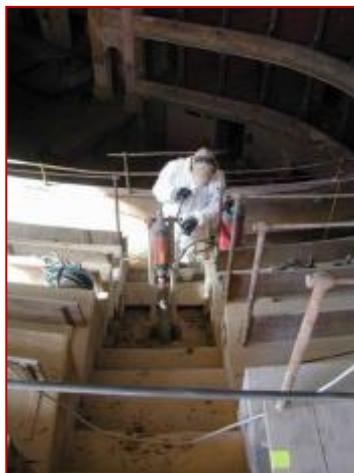
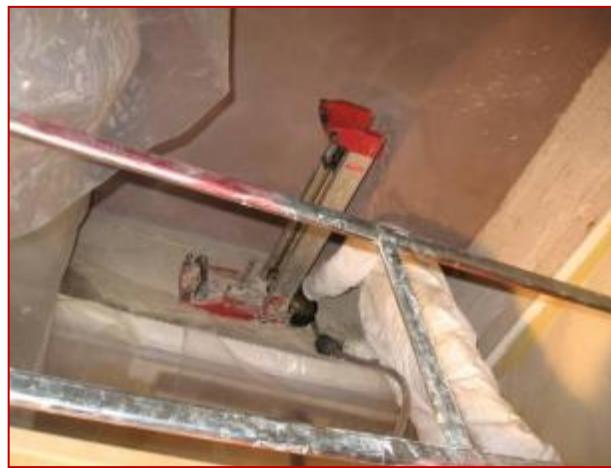
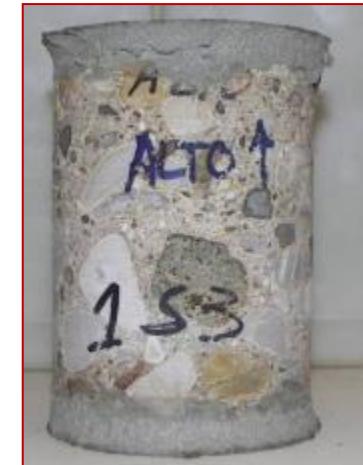
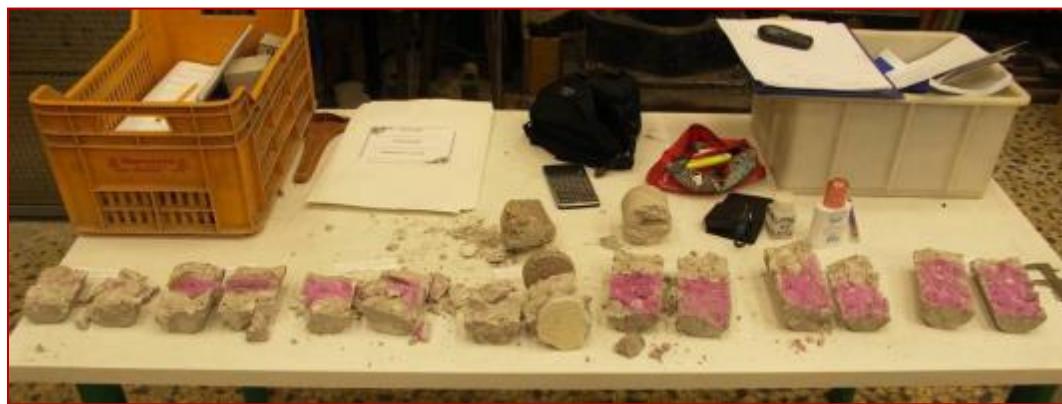
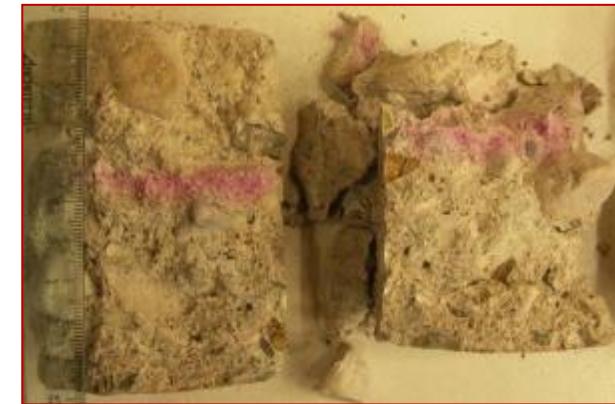
Investigations in situ on RC elements

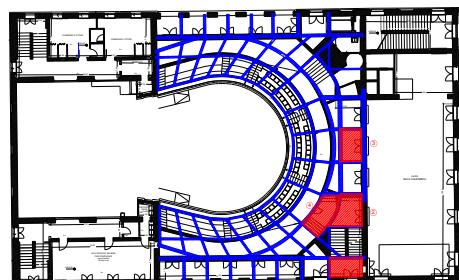
Retrofitting of RC structures:

- local FEM model

slab thickness = 10 cm
